# THE HIDDEN COST OF HYDROPOWER

Environmental hazards & risks of tunnelling, excavation  
& construction in Run of the River Hydropower Projects  
in Himachal Pradesh

A Dossier | June 2019

**Himdharma, Environment Research & Action Collective**

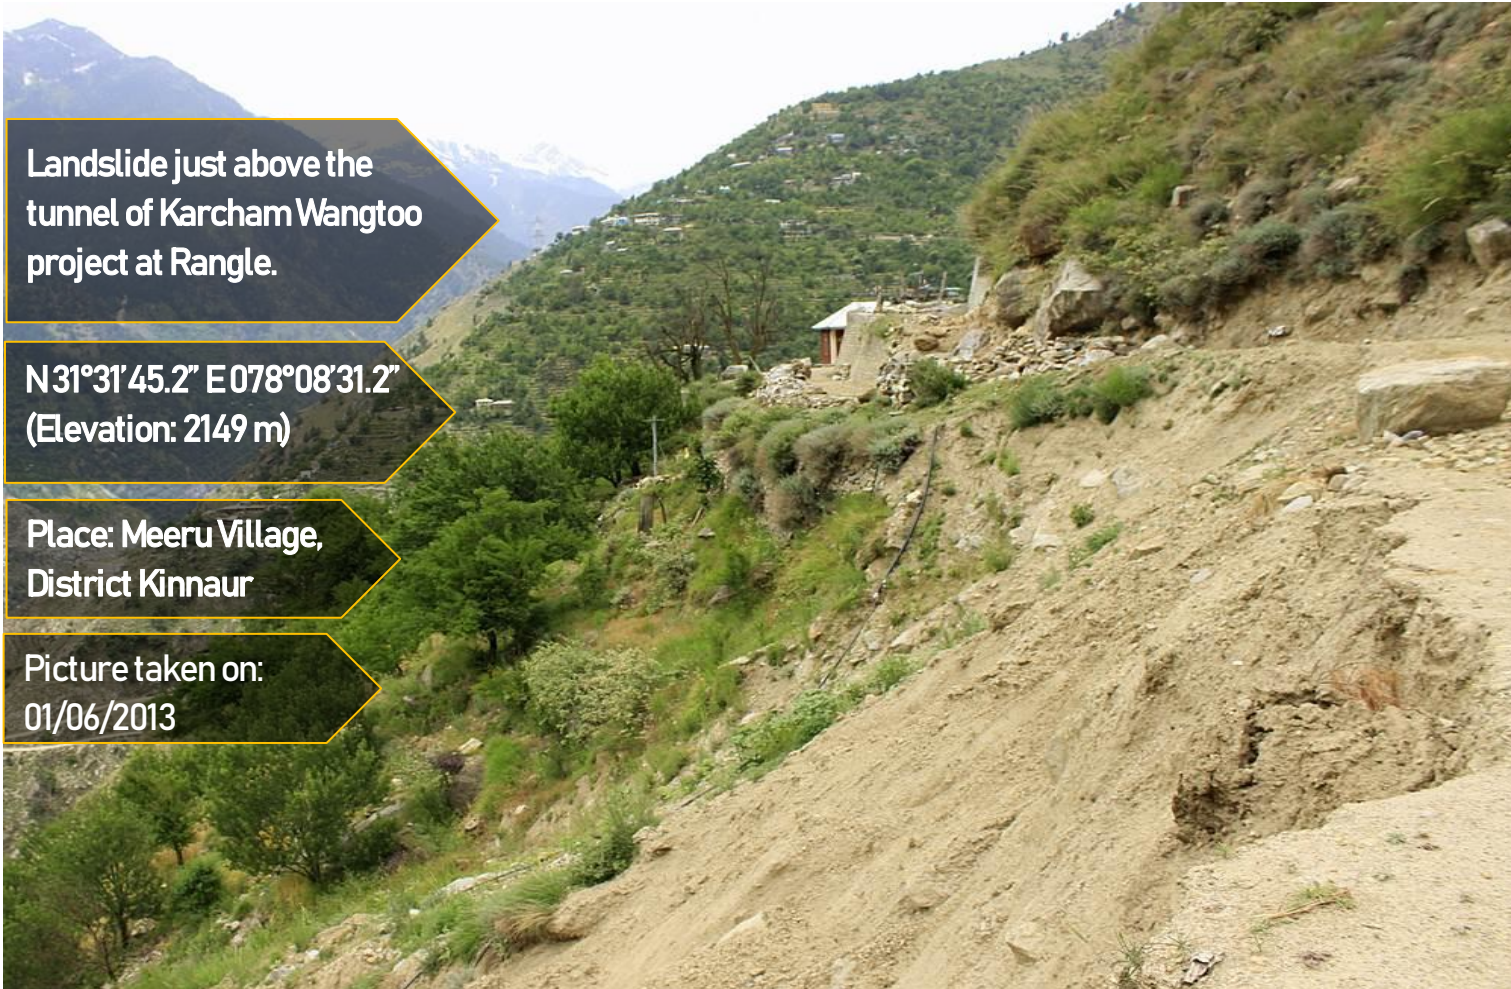
Place: Meeru Village,  
District Kinnaur

Landslide just above the tunnel of Karcham Wangtoo project at Rangle.

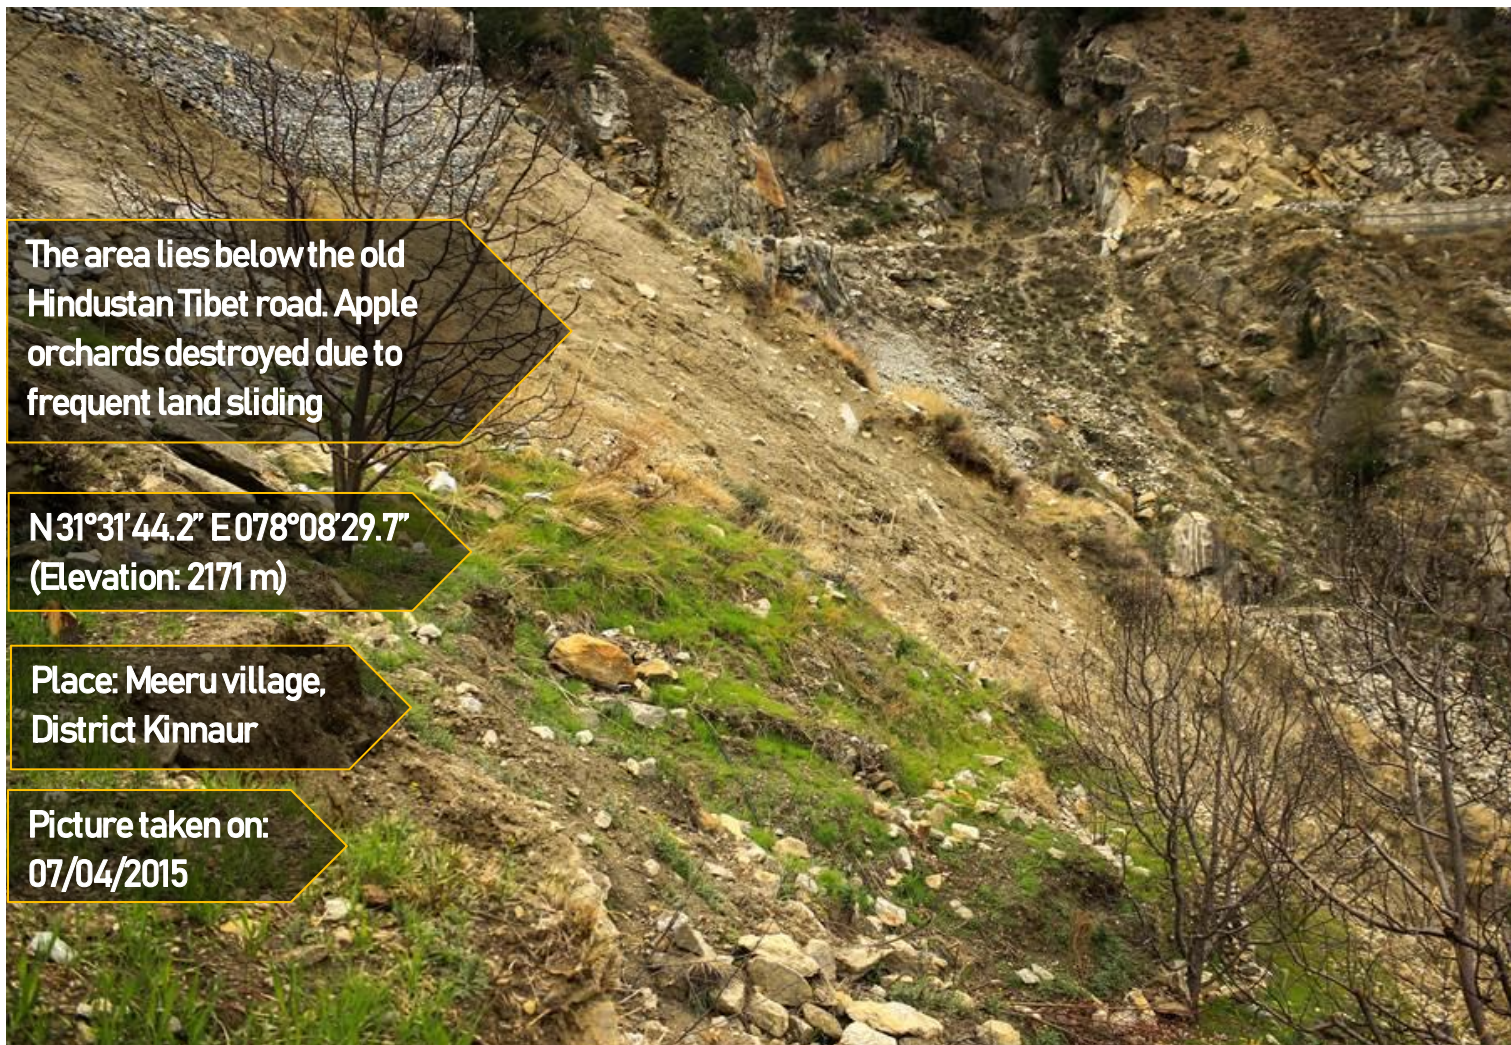
The area lies below the old Hindustan Tibet road. Apple orchards destroyed due to frequent land sliding

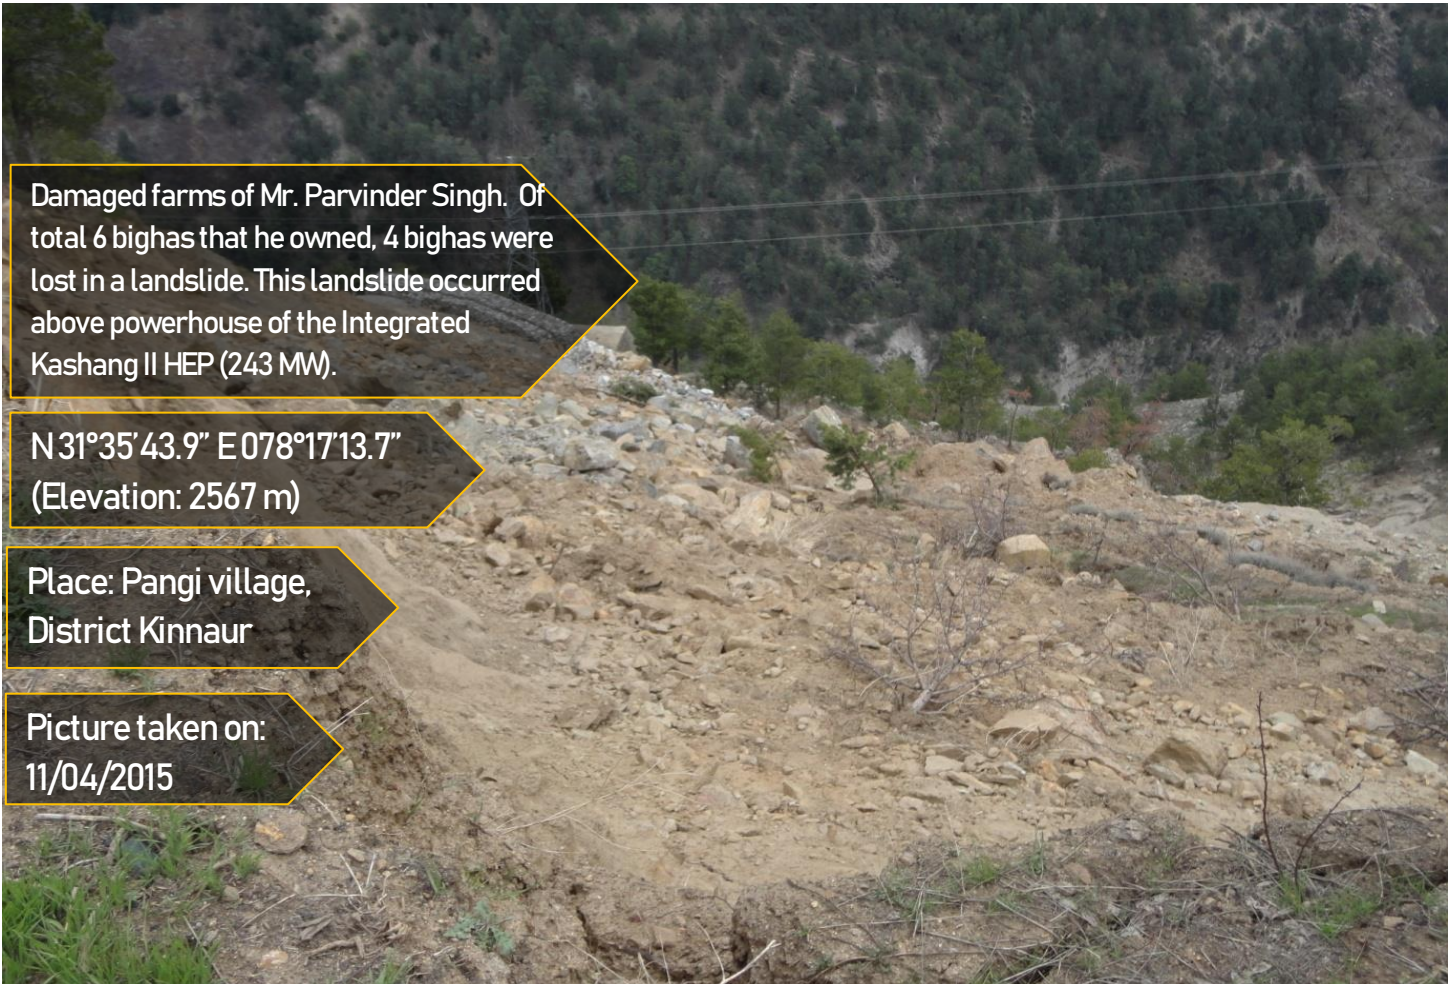
Place: Pangi village,  
District Kinnaur

Damaged farms of Mr. Parvinder Singh. Of total 6 bighas that he owned, 4 bighas were lost in a landslide. This landslide occurred above powerhouse of the Integrated Kashang II HEP (243 MW).

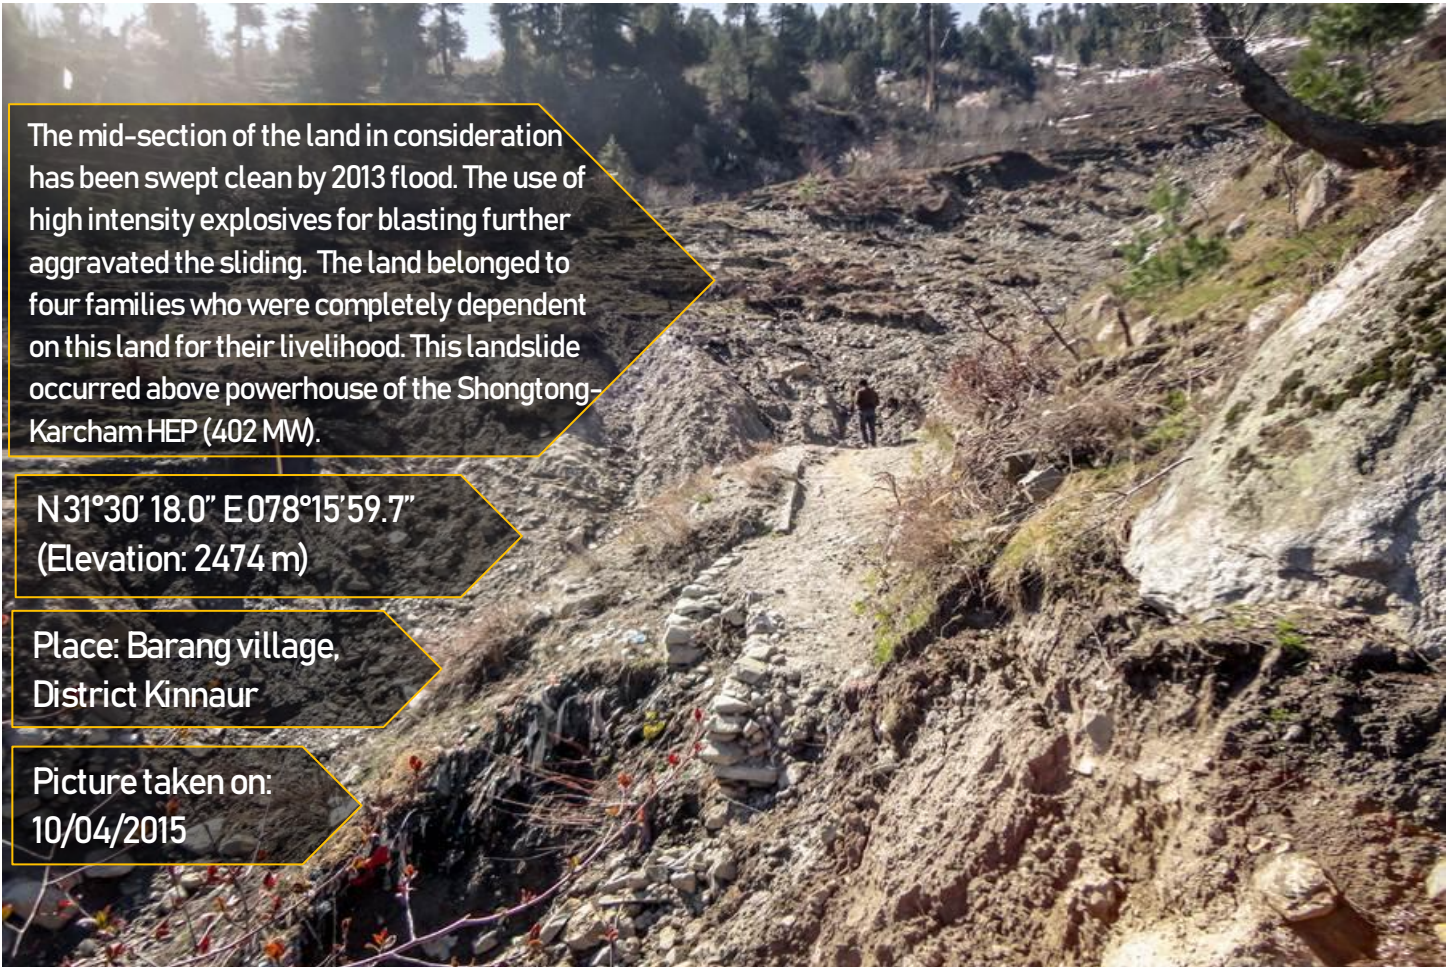
The mid-section of the land in consideration has been swept clean by 2013 flood. The use of high intensity explosives for blasting further aggravated the sliding. The land belonged to four families who were completely dependent on this land for their livelihood. This landslide occurred above powerhouse of the Shongtong-Karcham HEP (402 MW).

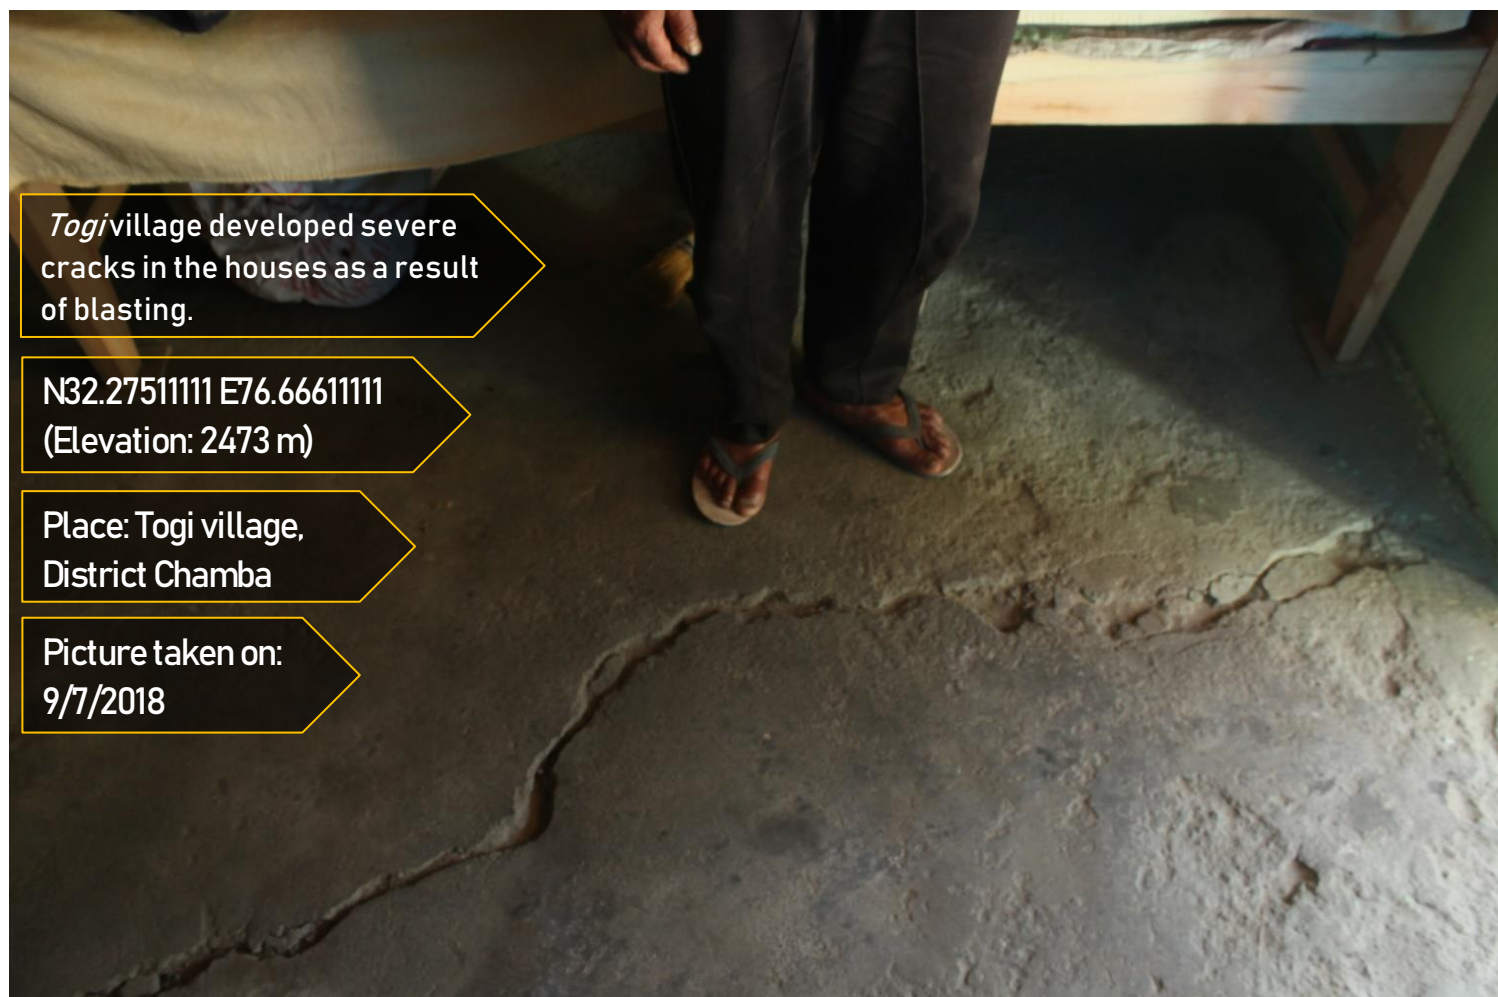
Place: Togi village,  
District Chamba

Togivillage developed severe cracks in the houses as a result of blasting.

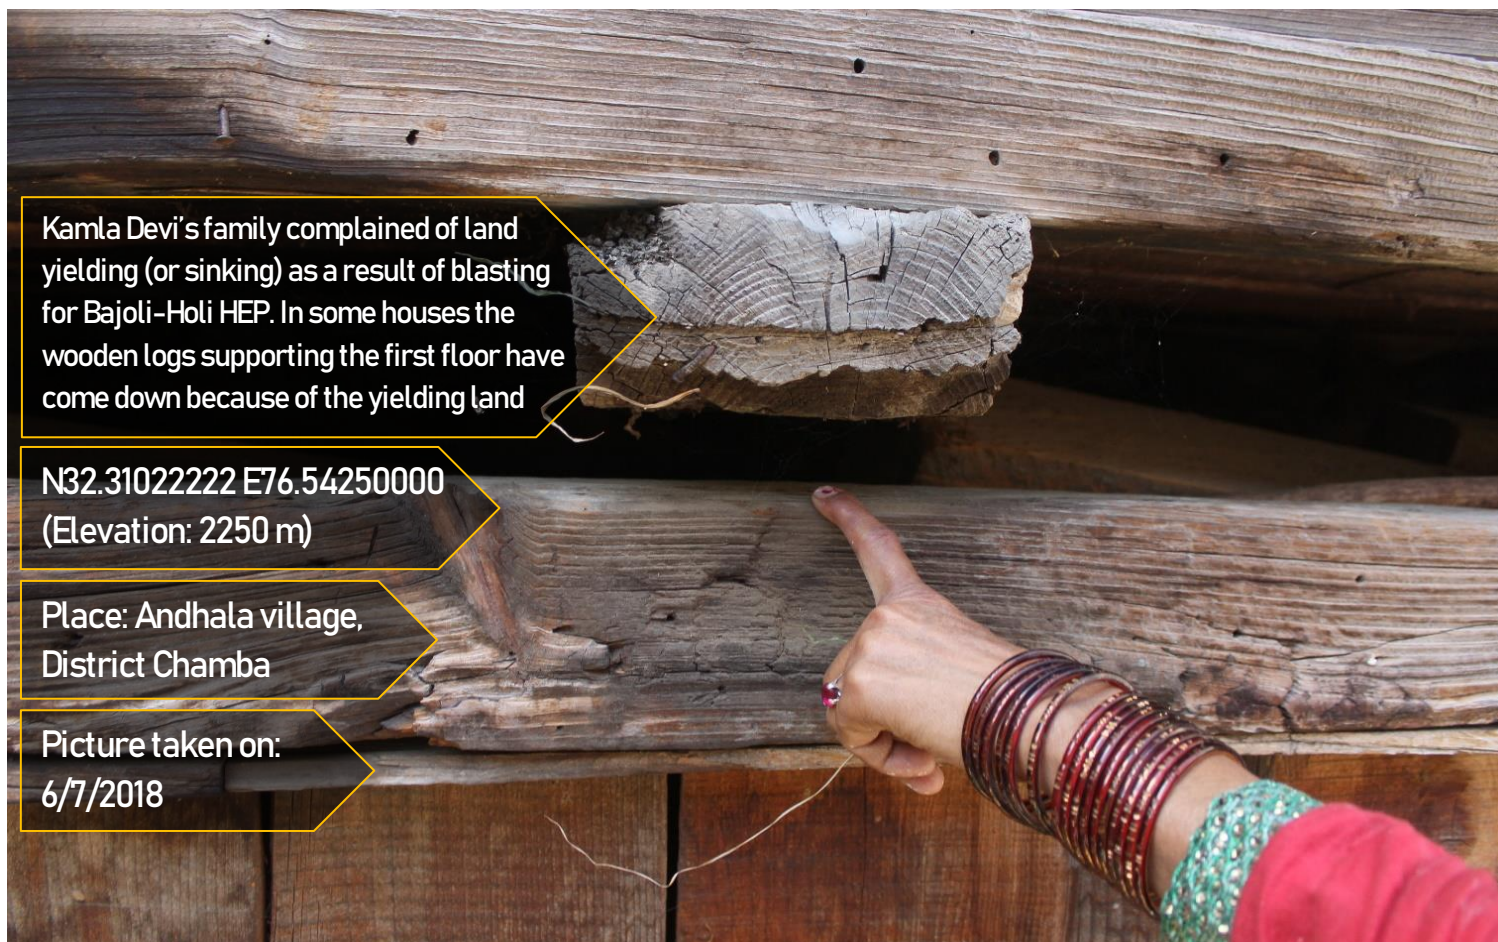
Place: Andhala village,  
District Chamba

Kamla Devi's family complained of land yielding (or sinking) as a result of blasting for Bajoli-Holi HEP. In some houses the wooden logs supporting the first floor have come down because of the yielding land

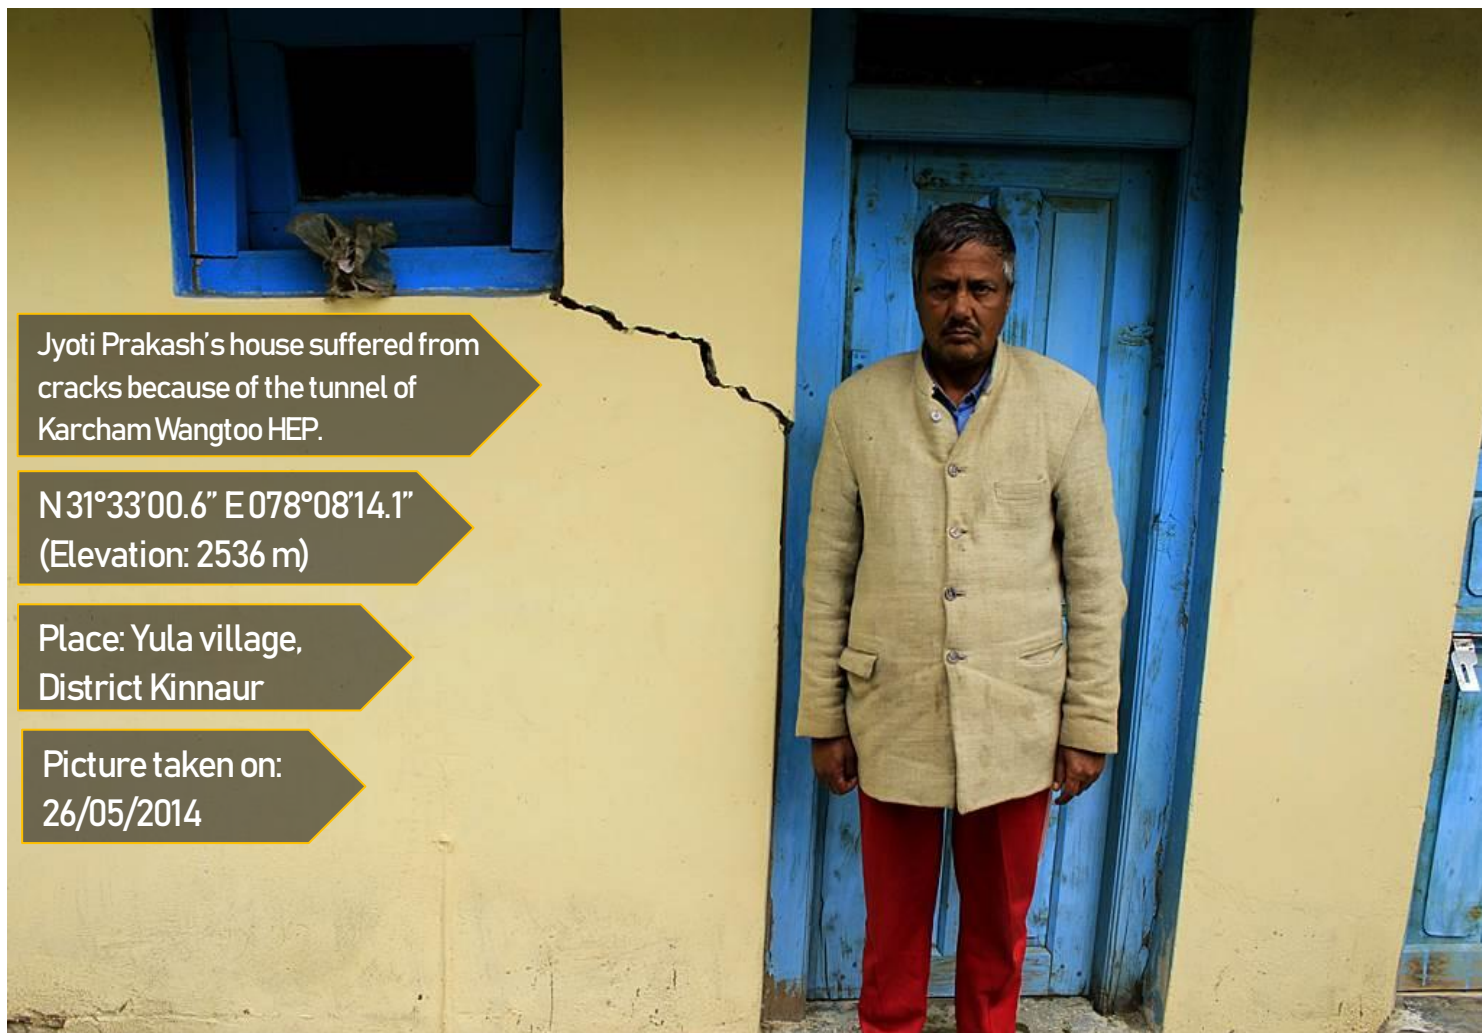
Place: Yula village,  
District Kinnaur

Jyoti Prakash's house suffered from cracks because of the tunnel of Karcham Wangtoo HEP.

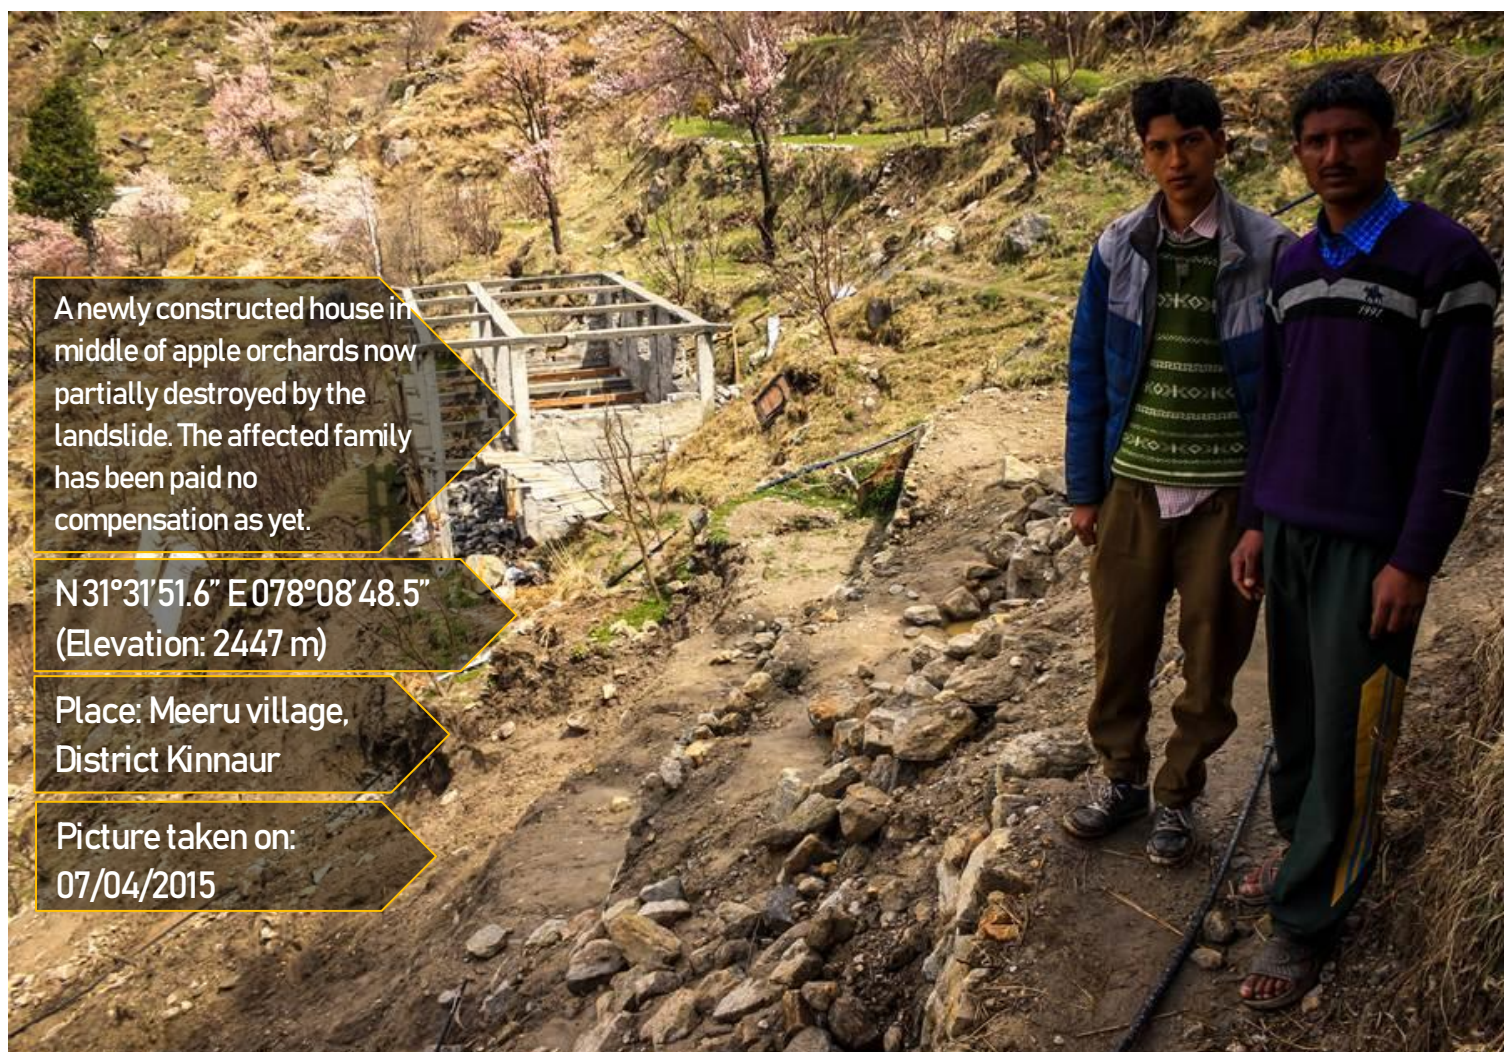
Place: Meeru village,  
District Kinnaur

A newly constructed house in middle of apple orchards now partially destroyed by the landslide. The affected family has been paid no compensation as yet.

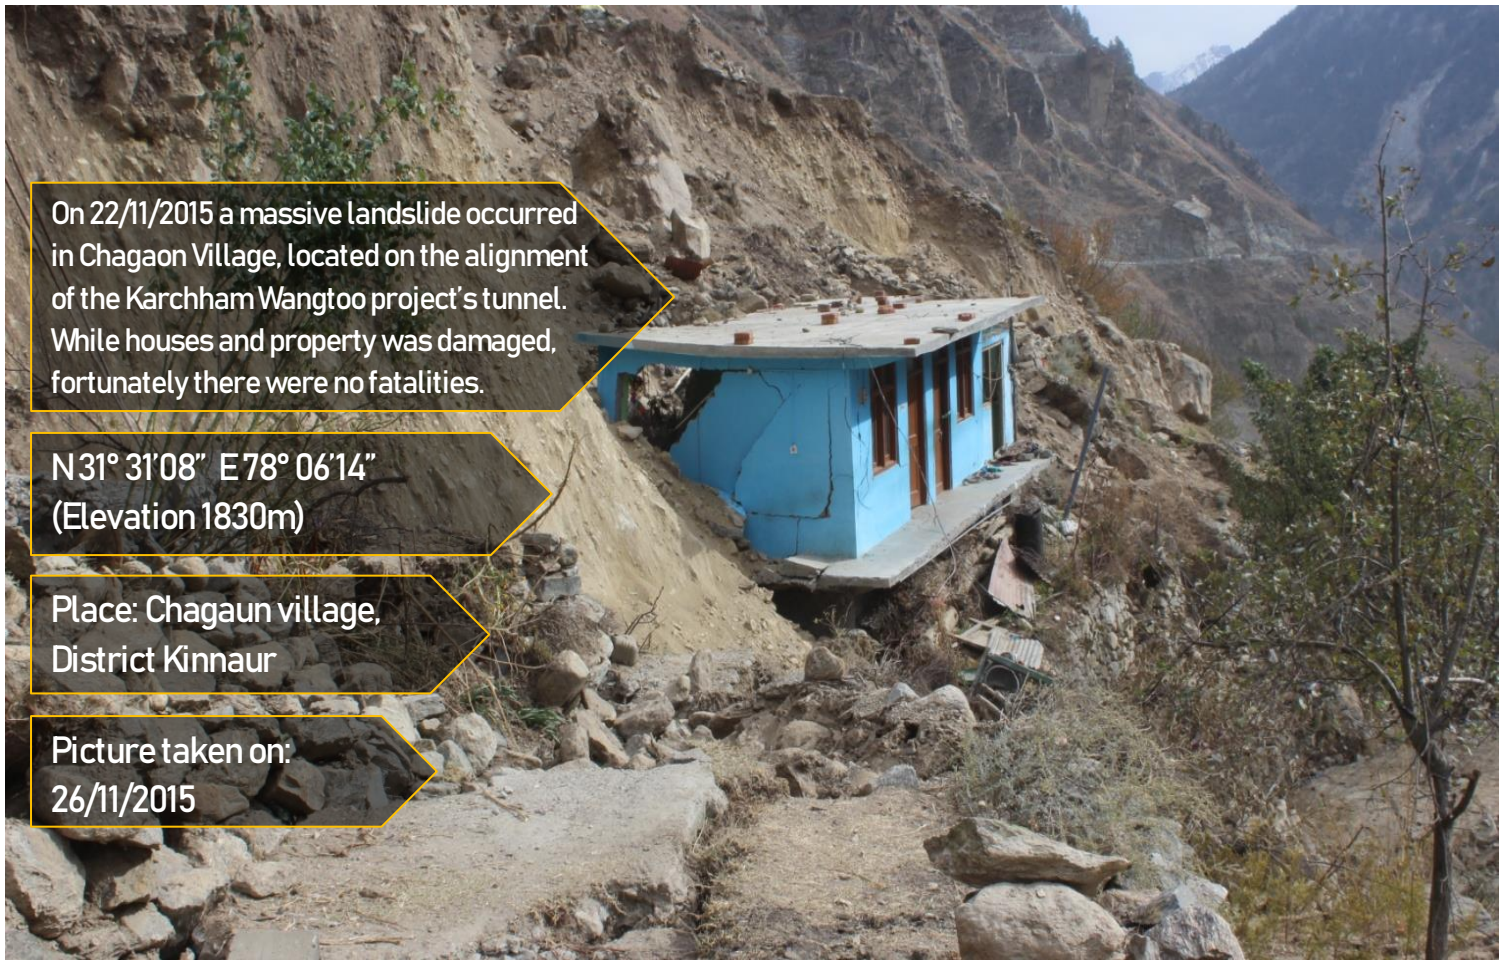
Place: Chagaun village,  
District Kinnaur

On 22/11/2015 a massive landslide occurred in Chagaon Village, located on the alignment of the Karchham Wangtoo project's tunnel. While houses and property was damaged, fortunately there were no fatalities.

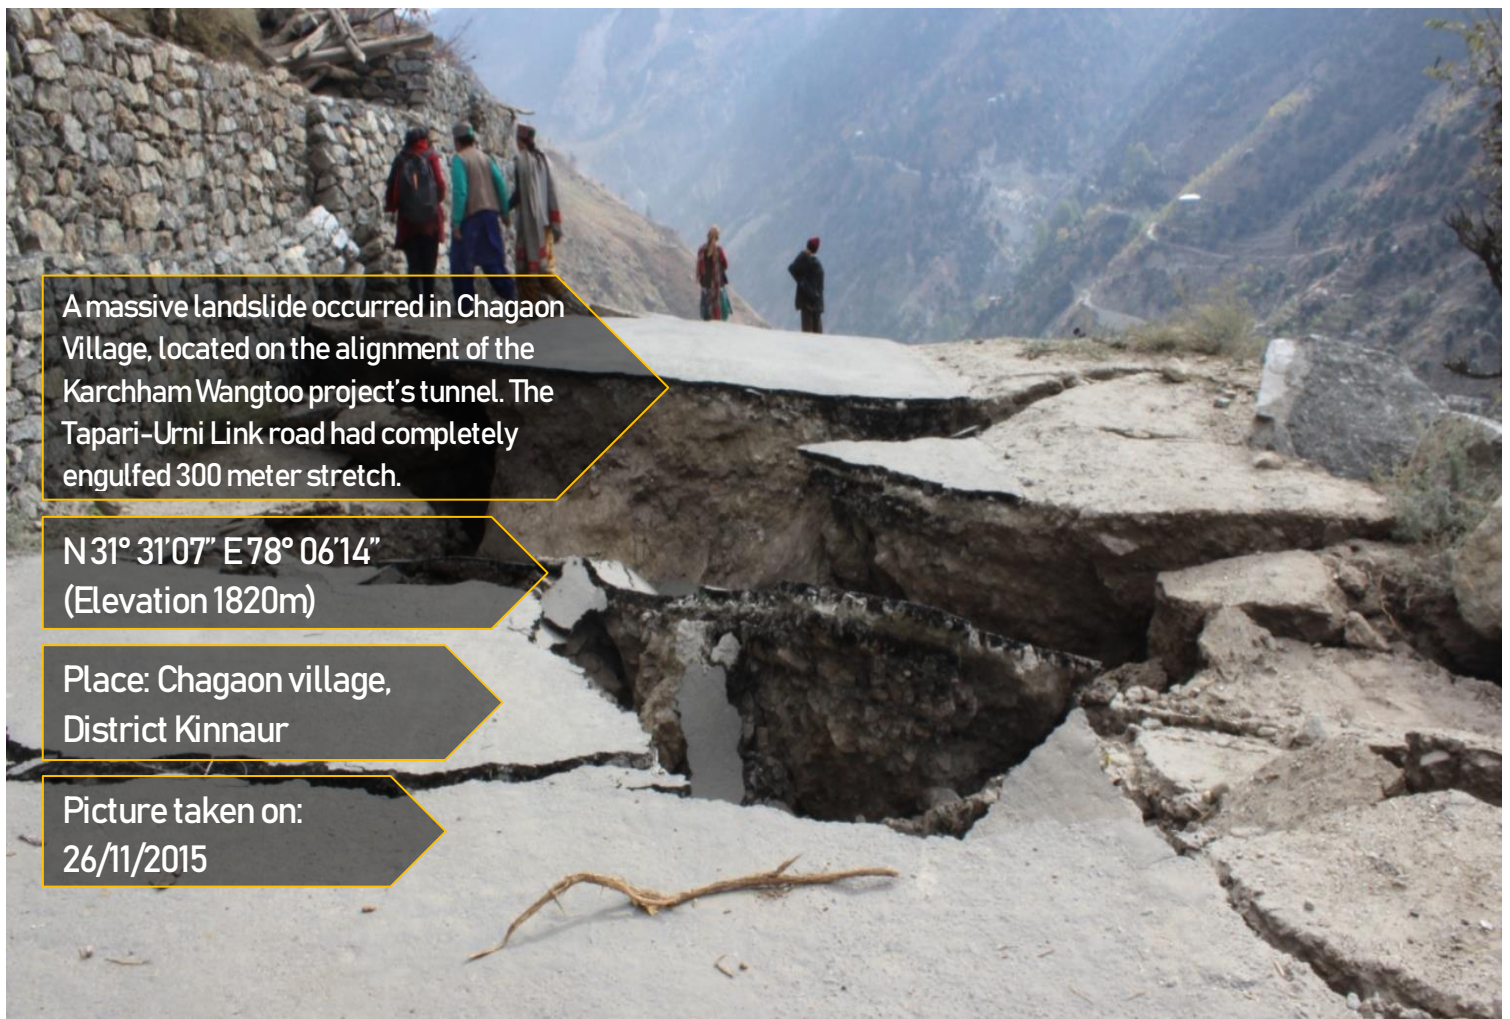
Place: Chagaon village,  
District Kinnaur

A massive landslide occurred in Chagaon Village, located on the alignment of the Karchham Wangtoo project's tunnel. The Tapari-Urni Link road had completely engulfed 300 meter stretch.

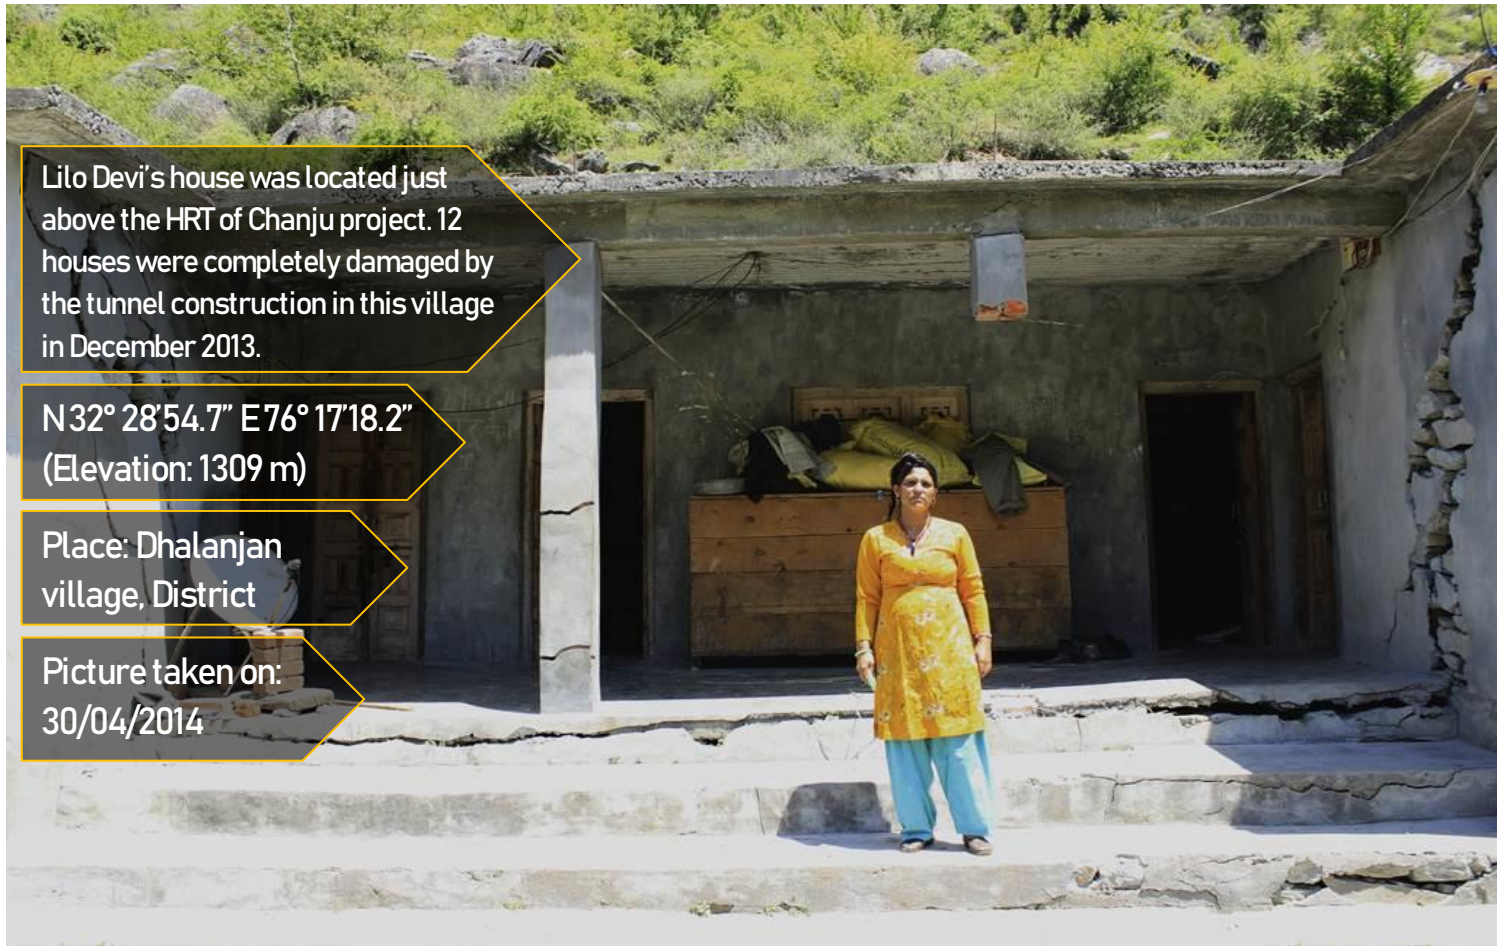
Place: Dhalanjan  
village, District

Lilo Devi's house was located just above the HRT of Chanju project. 12 houses were completely damaged by the tunnel construction in this village in December 2013.

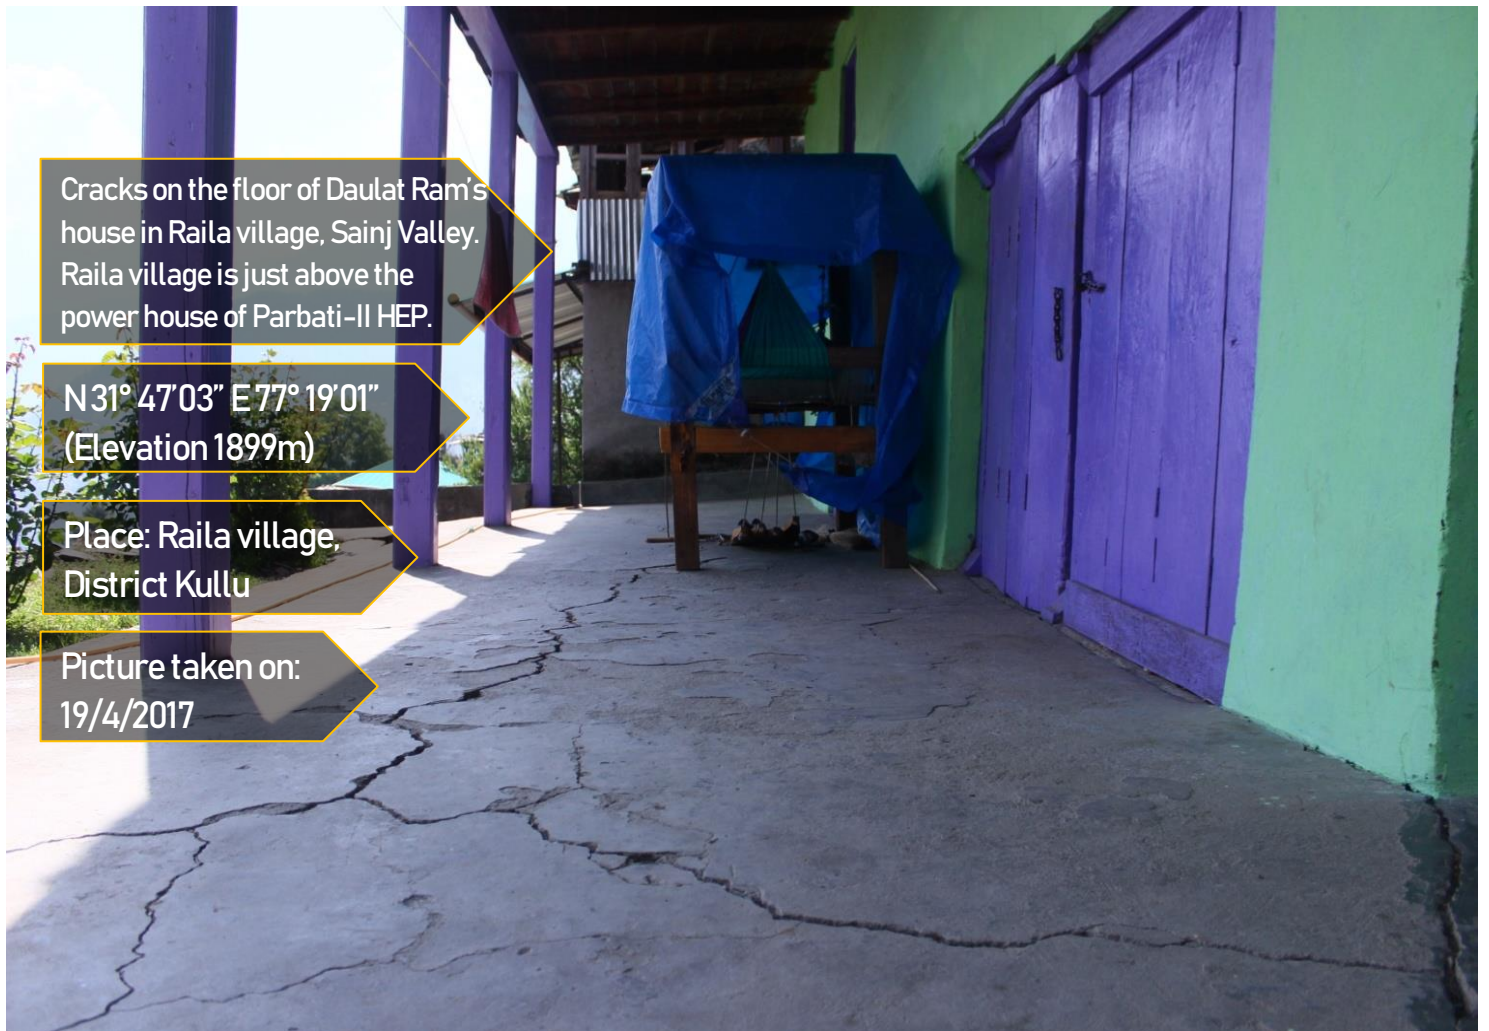
Cracks on the floor of Daulat Ram's house in Raila village, Sainj Valley. Raila village is just above the power house of Parbati-II HEP.

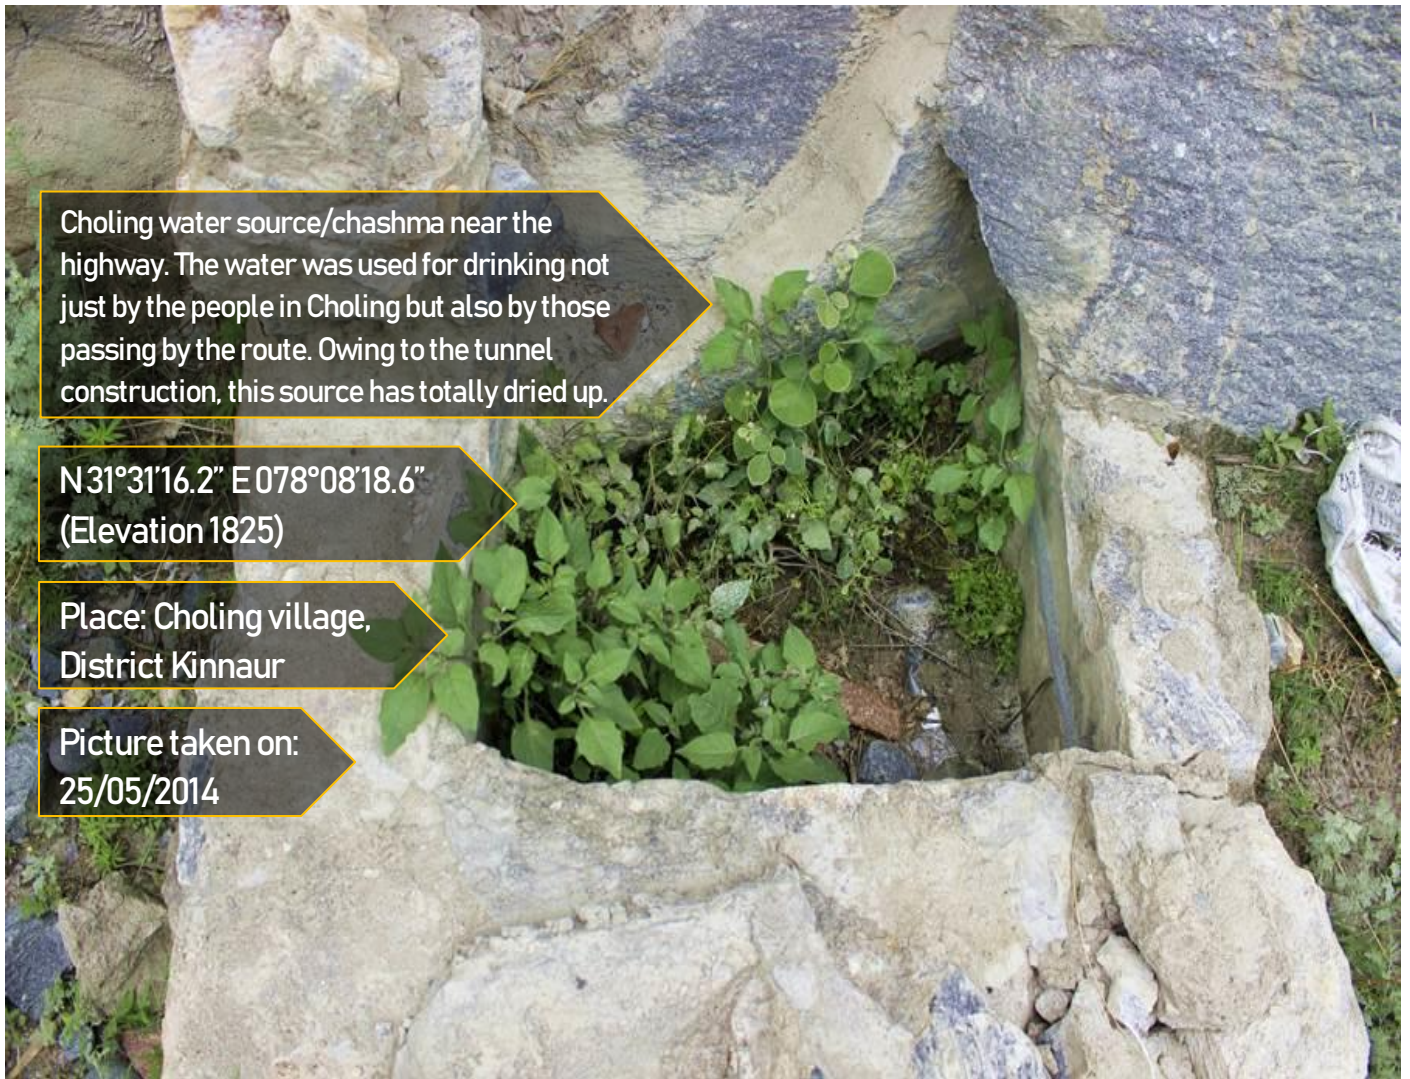
Place: Choling village,  
District Kinnaur

Choling water source/chashma near the highway. The water was used for drinking not just by the people in Choling but also by those passing by the route. Owing to the tunnel construction, this source has totally dried up.

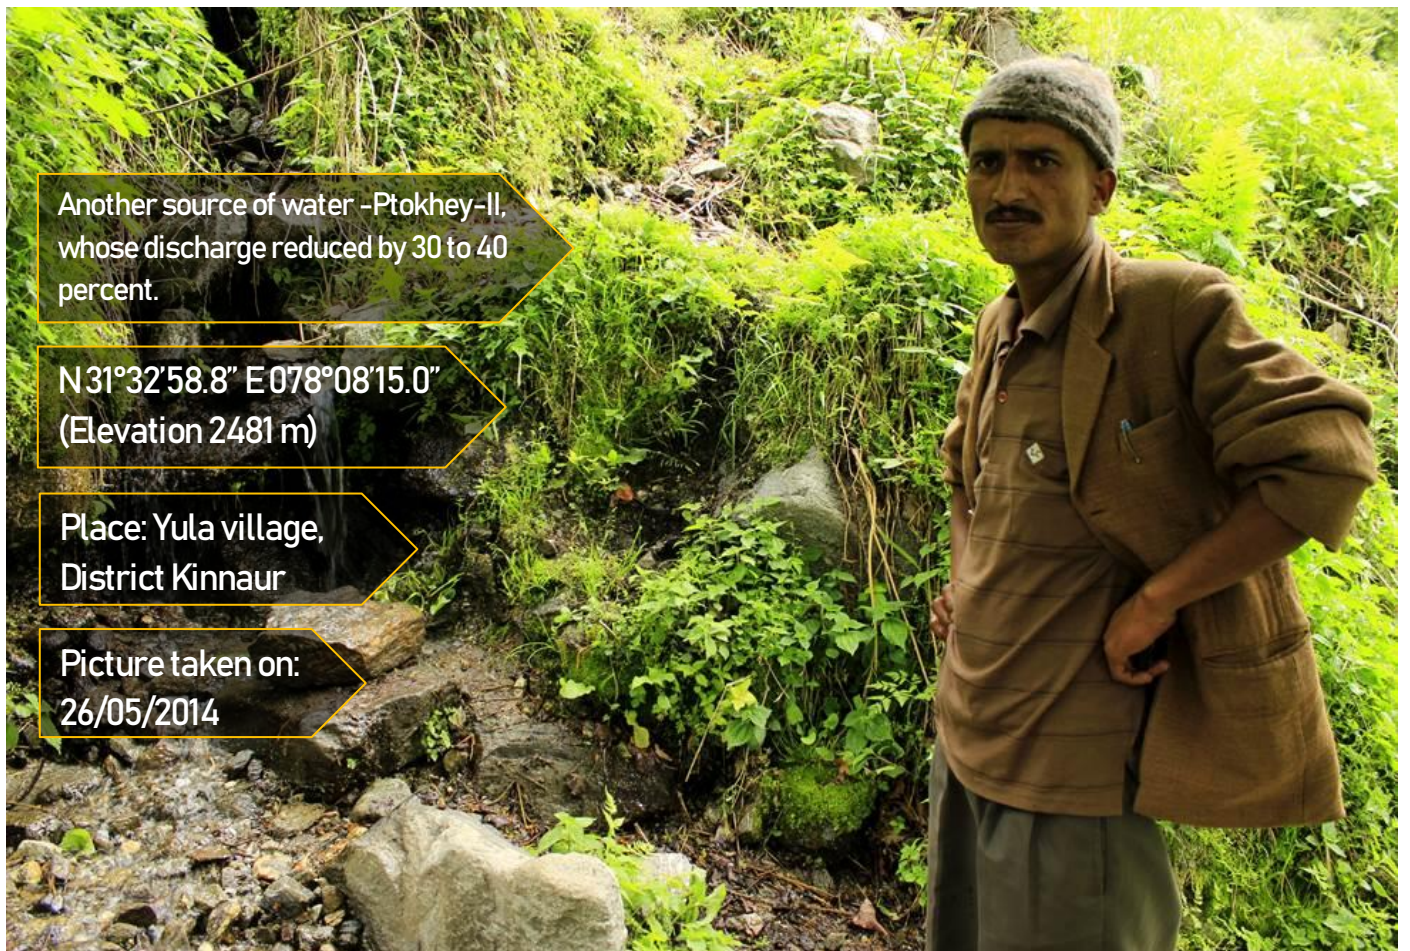
Place: Yula village,  
District Kinnaur

Another source of water -Ptokhey-II,  
whose discharge reduced by 30 to 40  
percent.

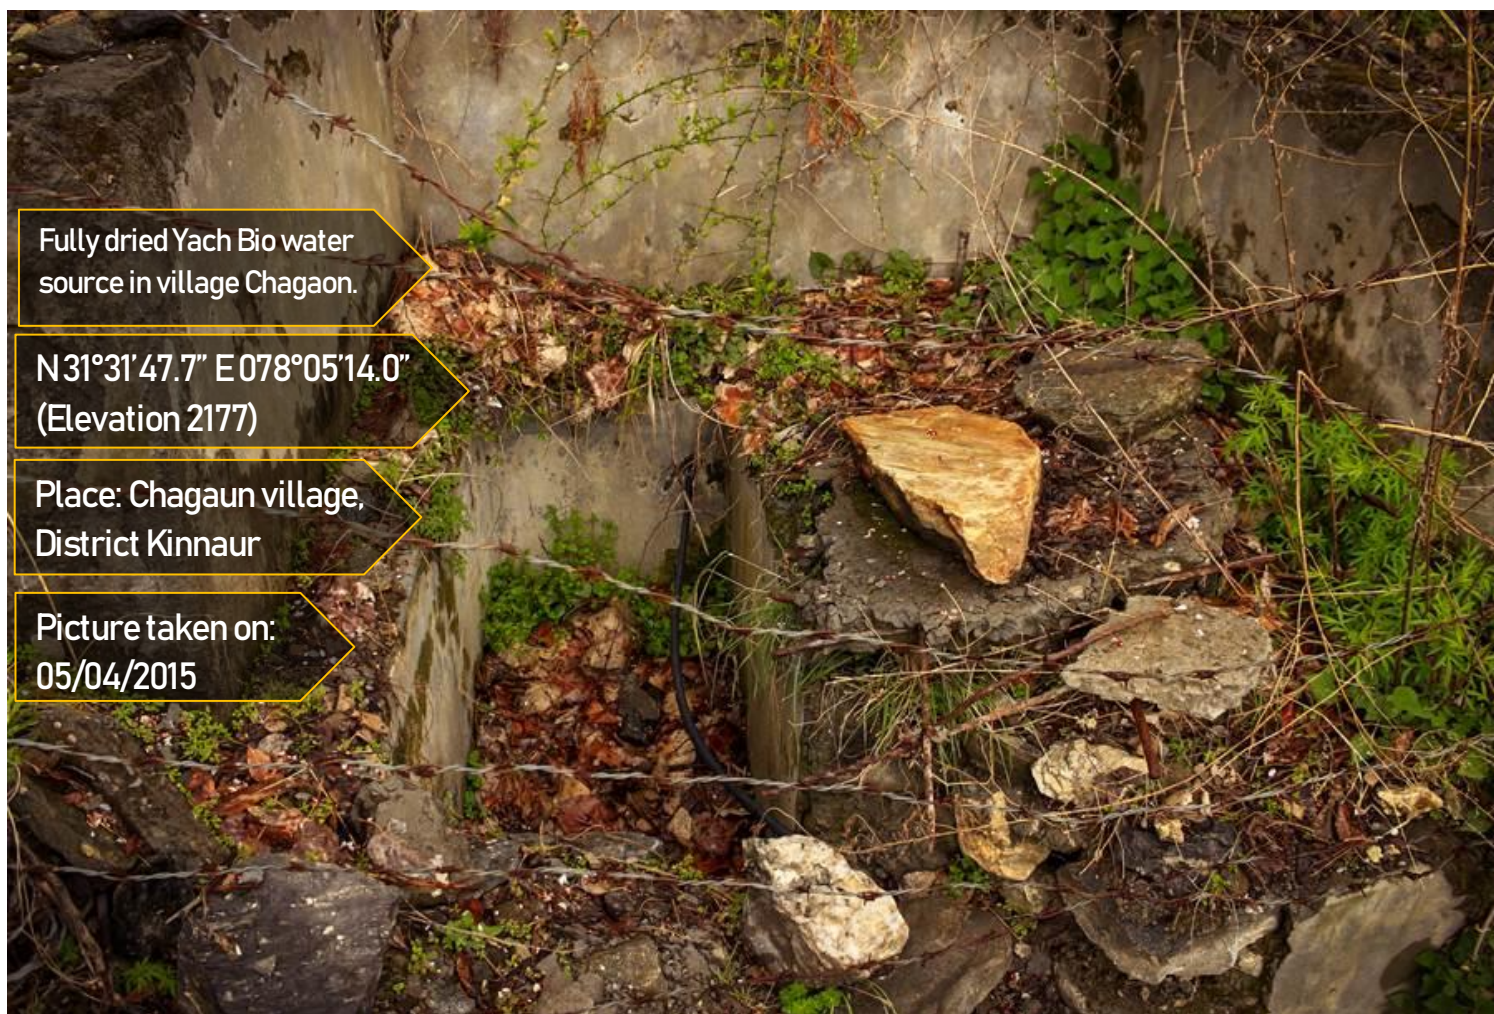
Place: Chagaun village,  
District Kinnaur

Fully dried Yach Bio water source in village Chagaon.
