# THE HIDDEN COST OF HYDROPOWER

Environmental hazards & risks of tunnelling, excavation  
& construction in Run of the River Hydropower Projects  
in Himachal Pradesh

A Dossier | June 2019

**Himdharma, Environment Research & Action Collective**

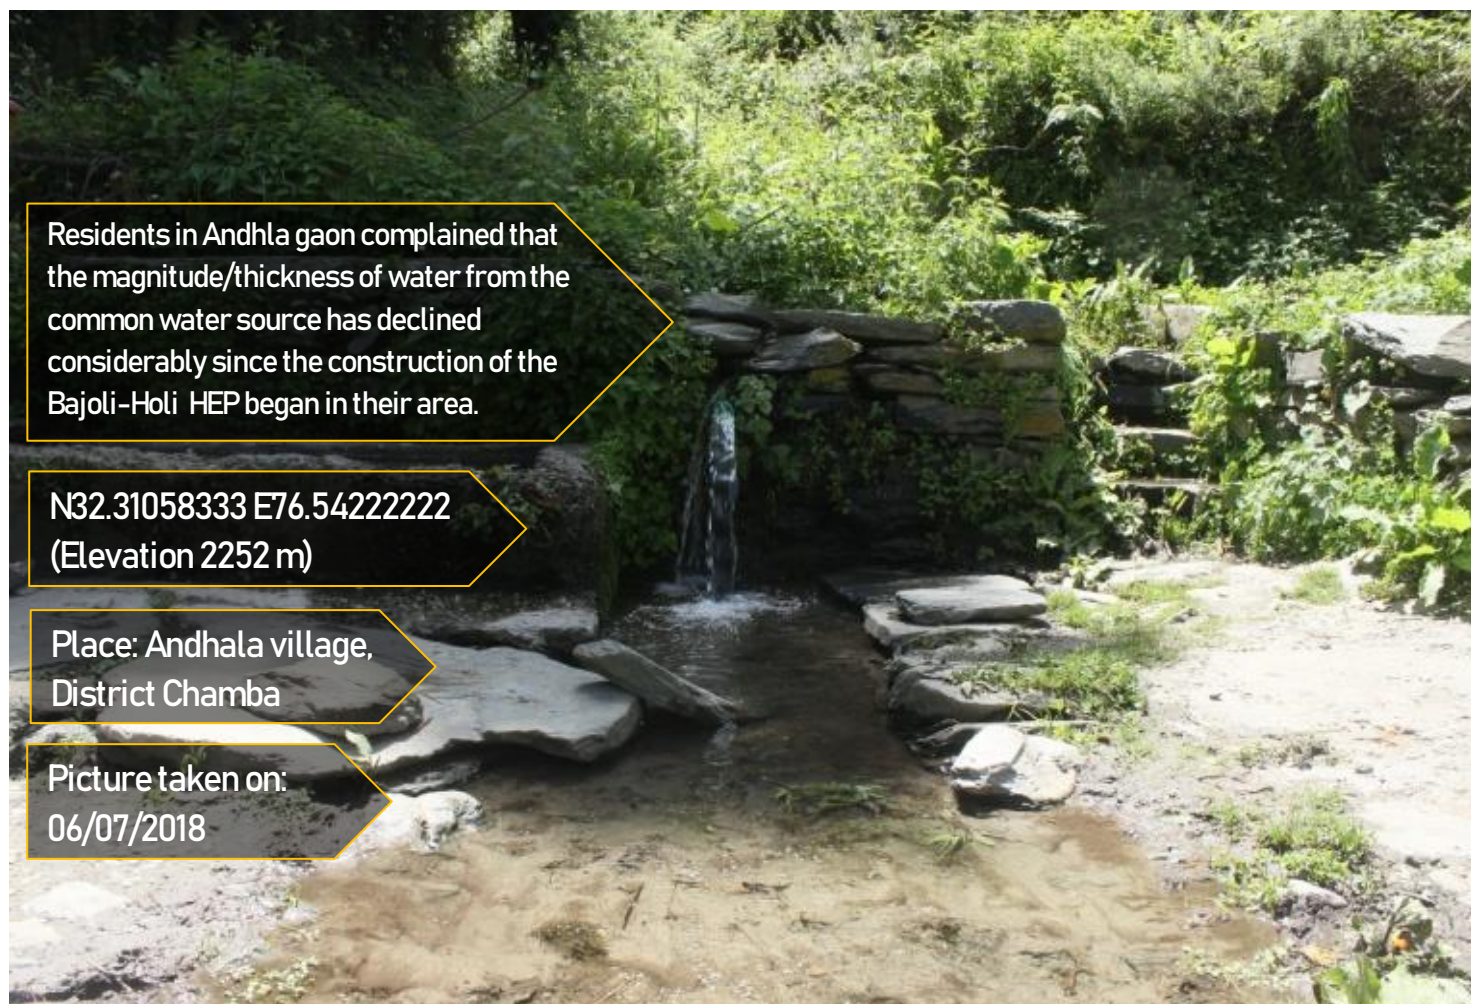
Residents in Andhla gaon complained that the magnitude/thickness of water from the common water source has declined considerably since the construction of the Bajoli-Holi HEP began in their area.

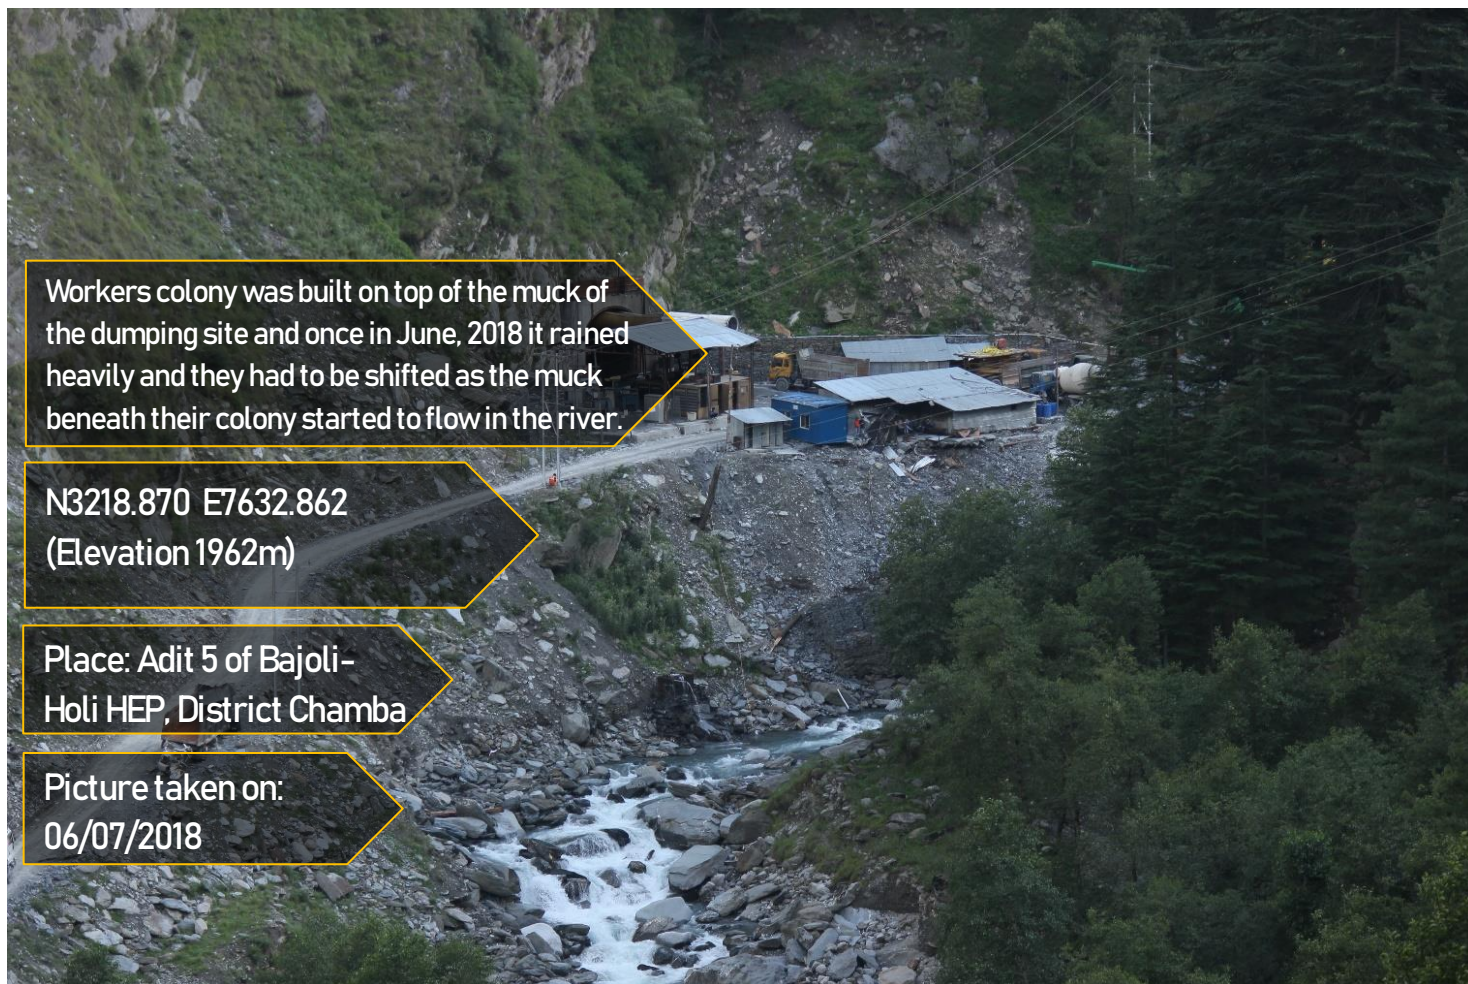
Place: Adit 5 of Bajoli-  
Holi HEP, District Chamba

Workers colony was built on top of the muck of the dumping site and once in June, 2018 it rained heavily and they had to be shifted as the muck beneath their colony started to flow in the river.

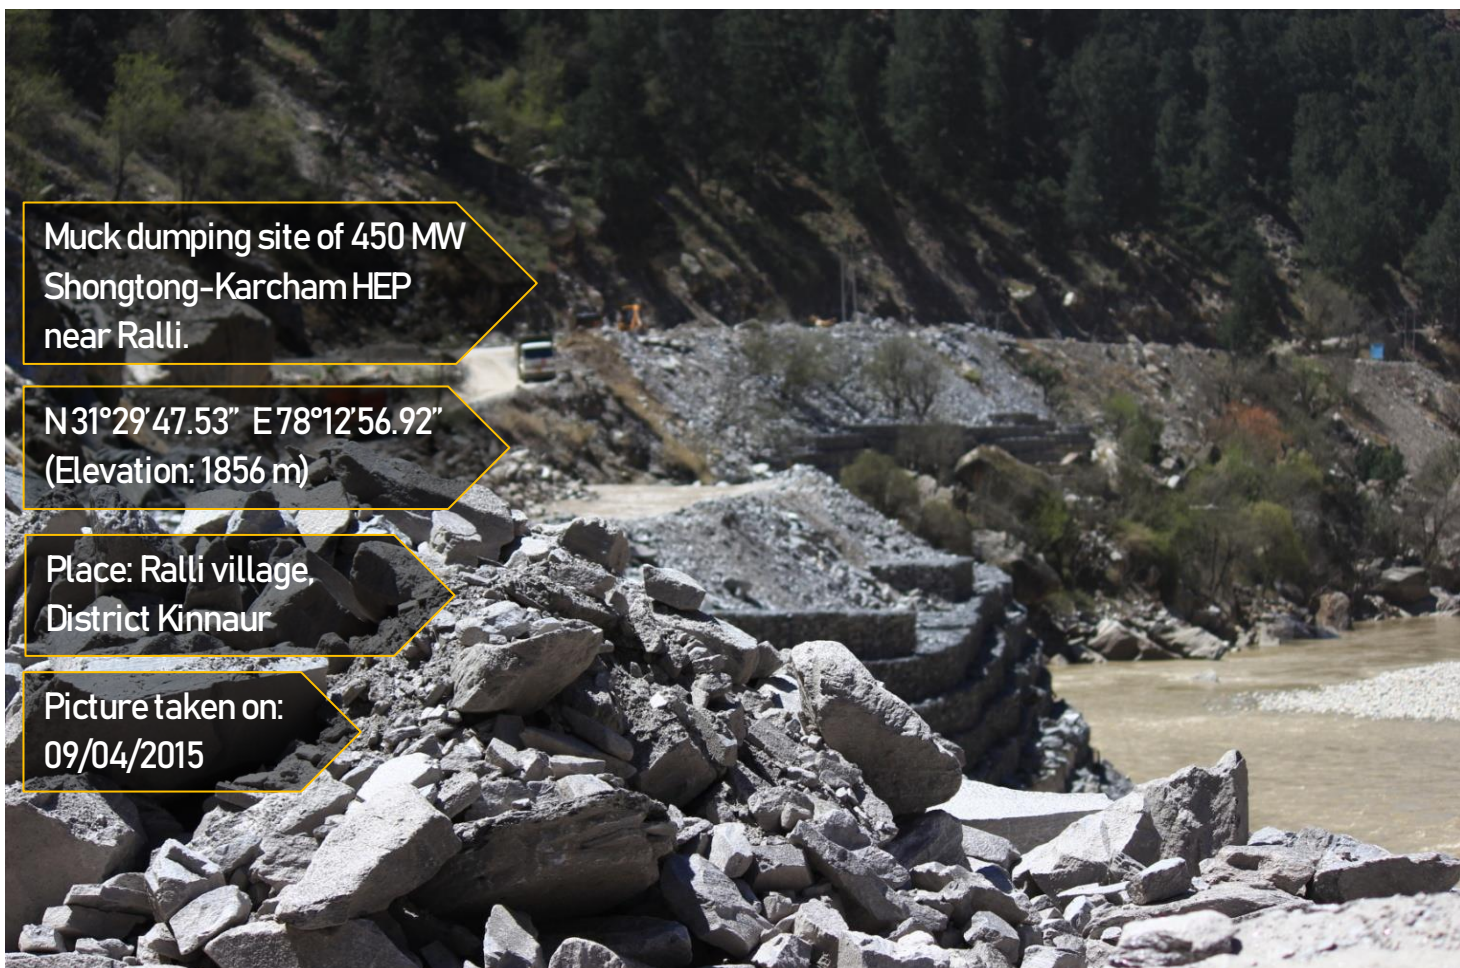
Muck dumping site of 450 MW  
Shongtong-Karcham HEP  
near Ralli.

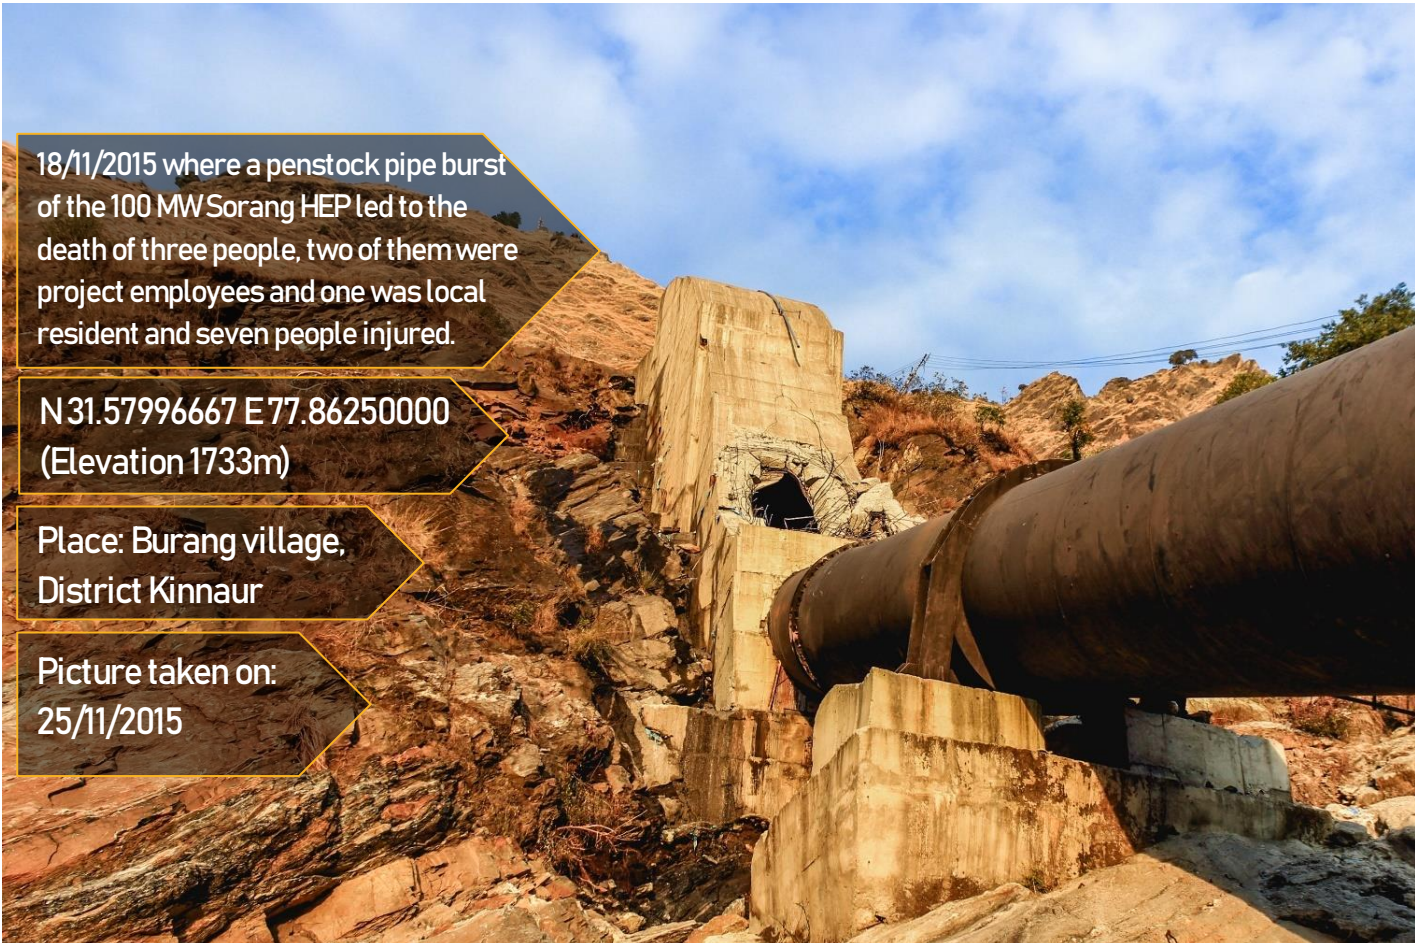
Place: Burang village,  
District Kinnaur

18/11/2015 where a penstock pipe burst of the 100 MW Sorang HEP led to the death of three people, two of them were project employees and one was local resident and seven people injured.

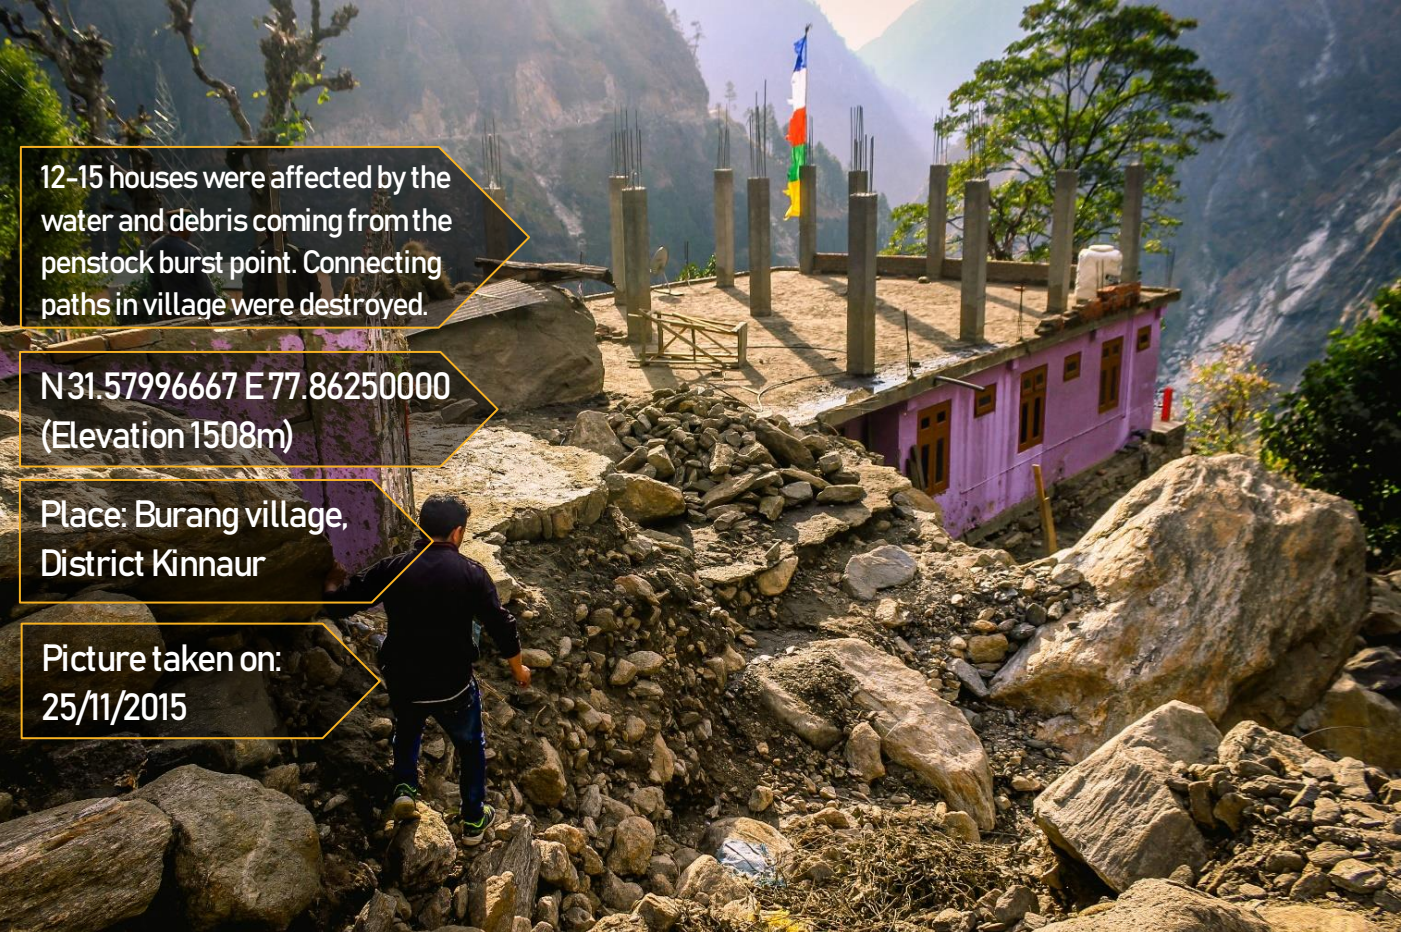
Place: Burang village,  
District Kinnaur

12-15 houses were affected by the water and debris coming from the penstock burst point. Connecting paths in village were destroyed.

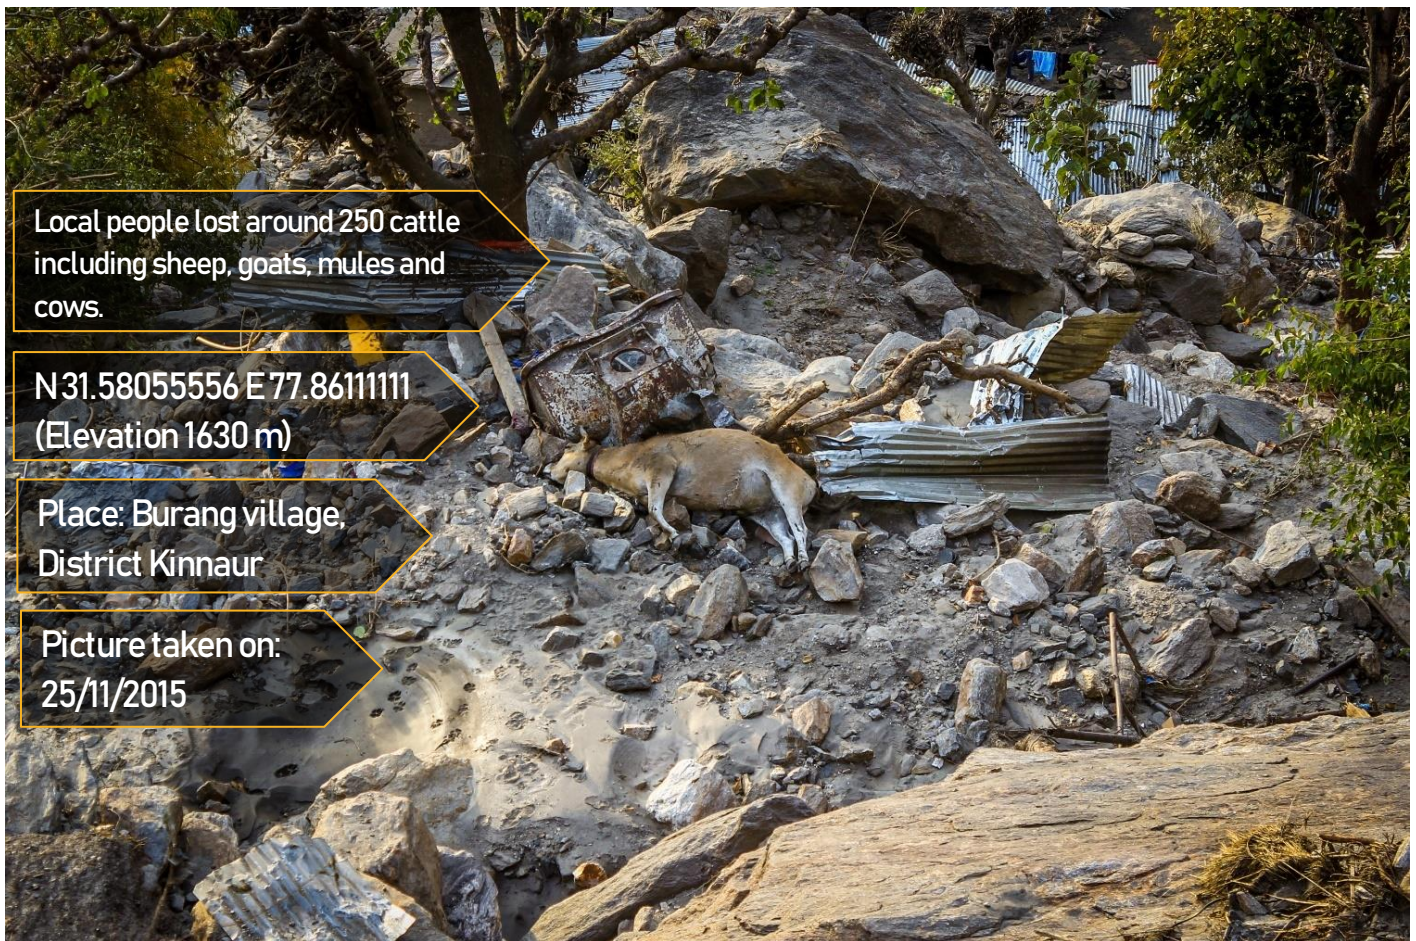
Place: Burang village,  
District Kinnaur

Local people lost around 250 cattle including sheep, goats, mules and cows.

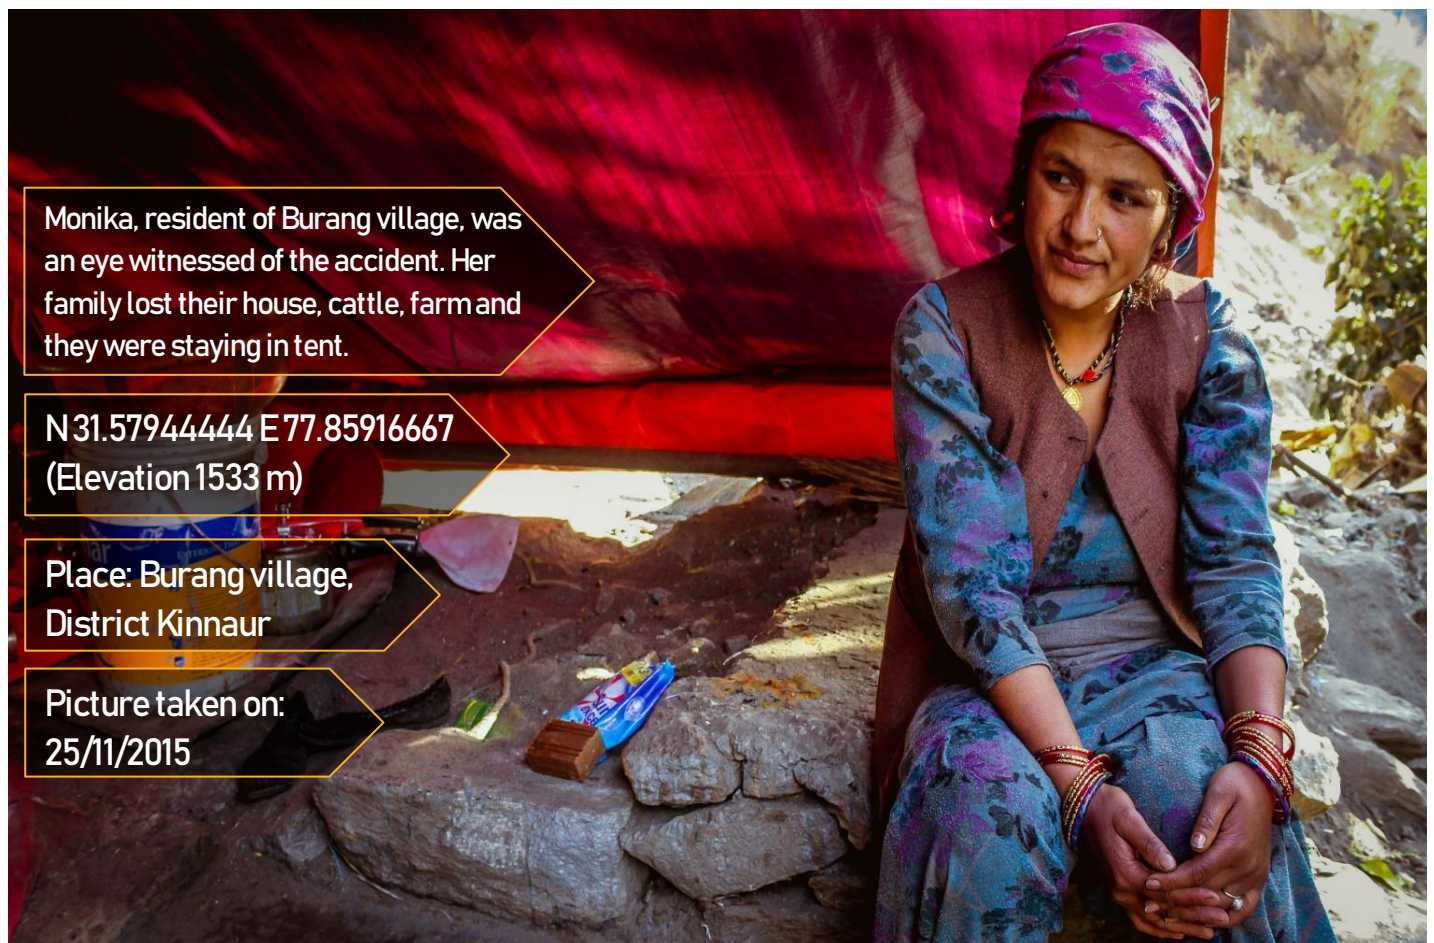
Place: Burang village,  
District Kinnaur

Monika, resident of Burang village, was an eye witness of the accident. Her family lost their house, cattle, farm and they were staying in tent.

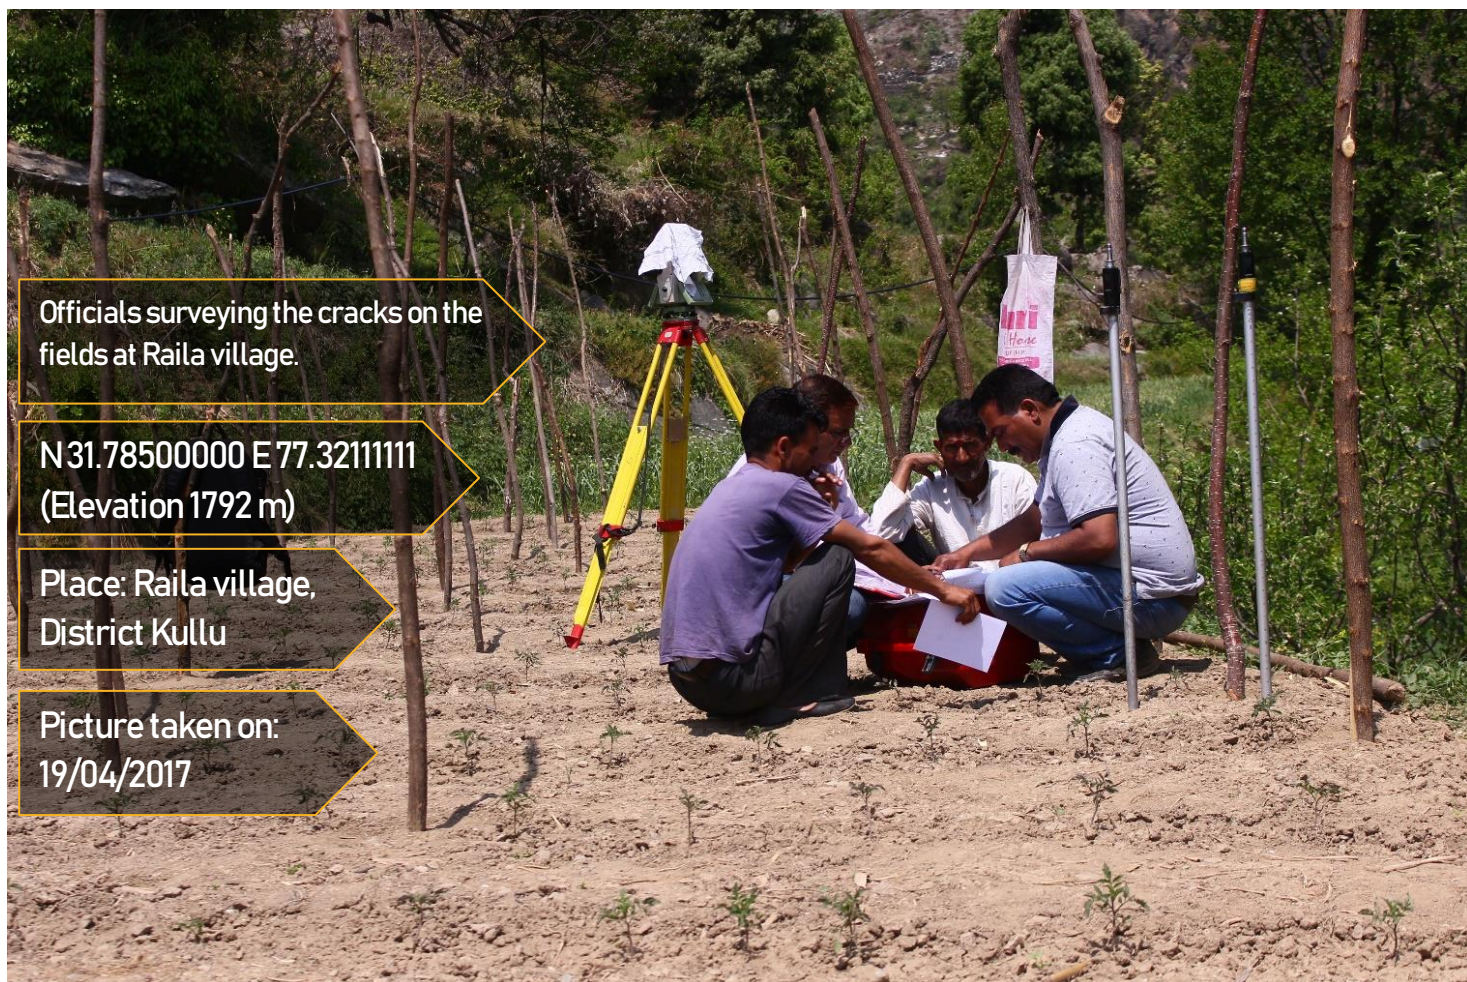
Place: Raila village,  
District Kullu

Officials surveying the cracks on the fields at Raila village.

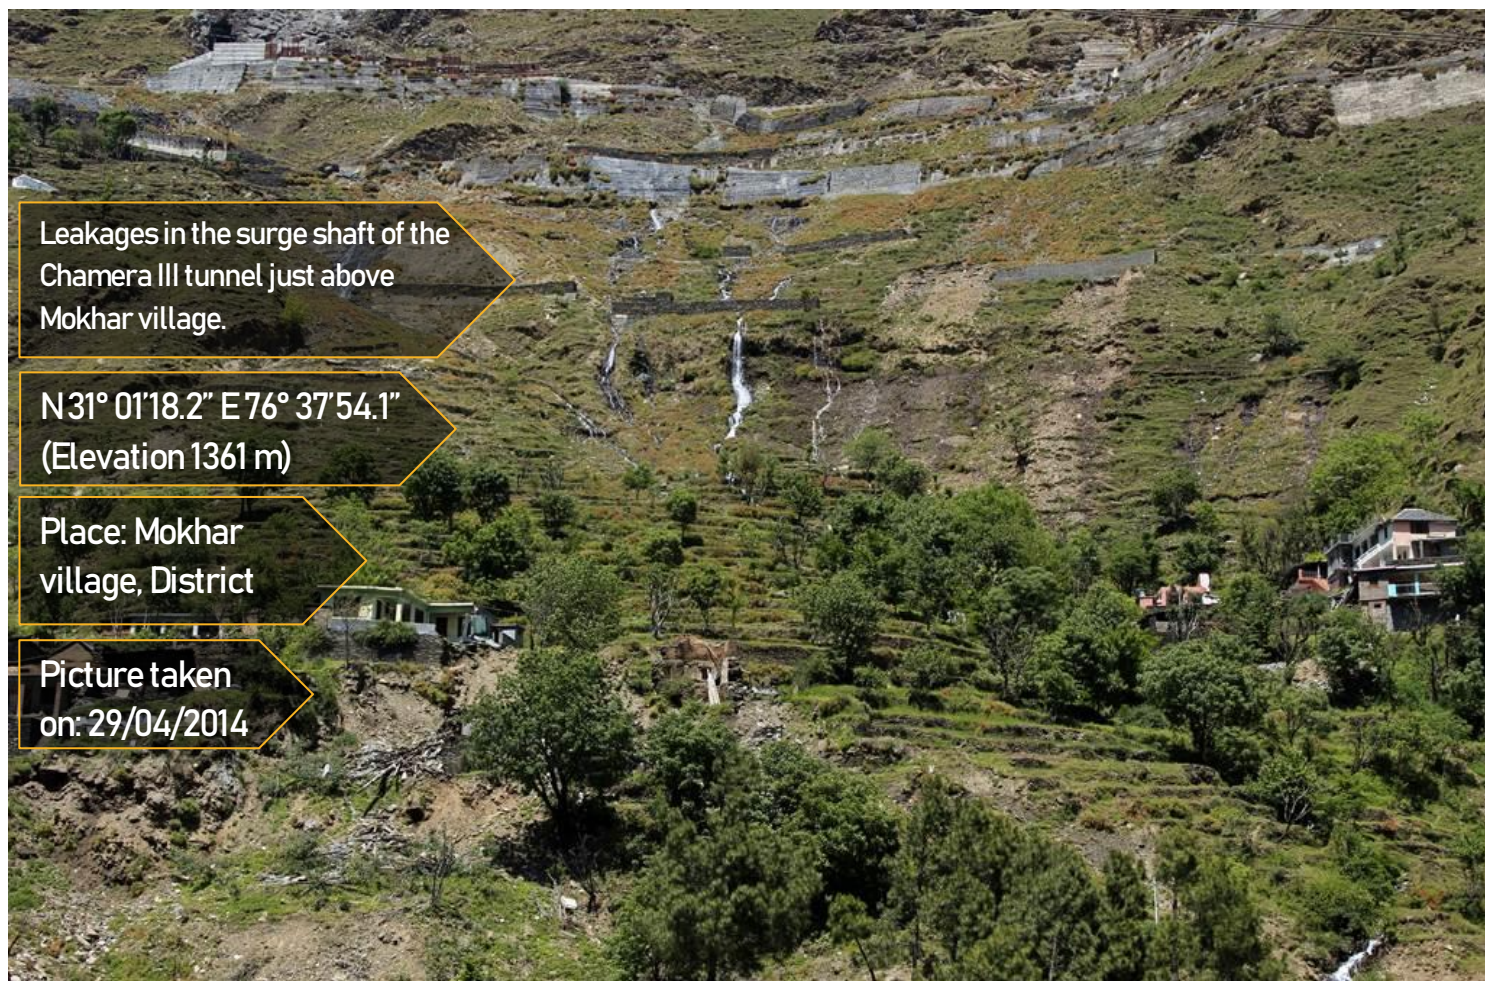
Place: Mokhar  
village, District

Leakages in the surge shaft of the  
Chamera III tunnel just above  
Mokhar village.

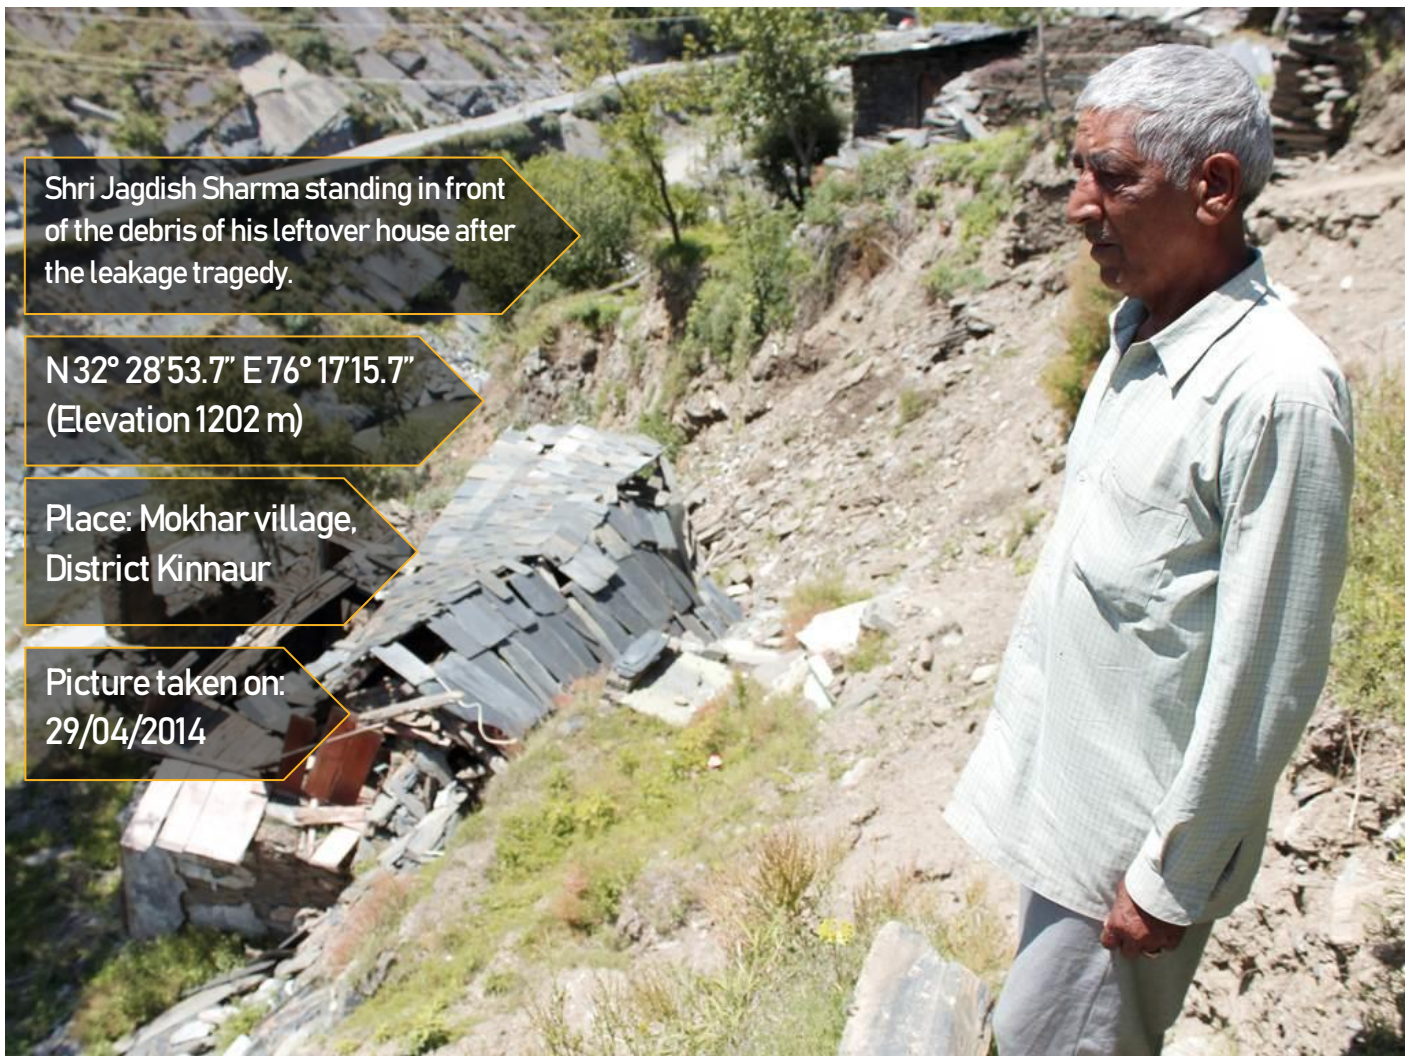
Place: Mokhar village,  
District Kinnaur

Shri Jagdish Sharma standing in front of the debris of his leftover house after the leakage tragedy.

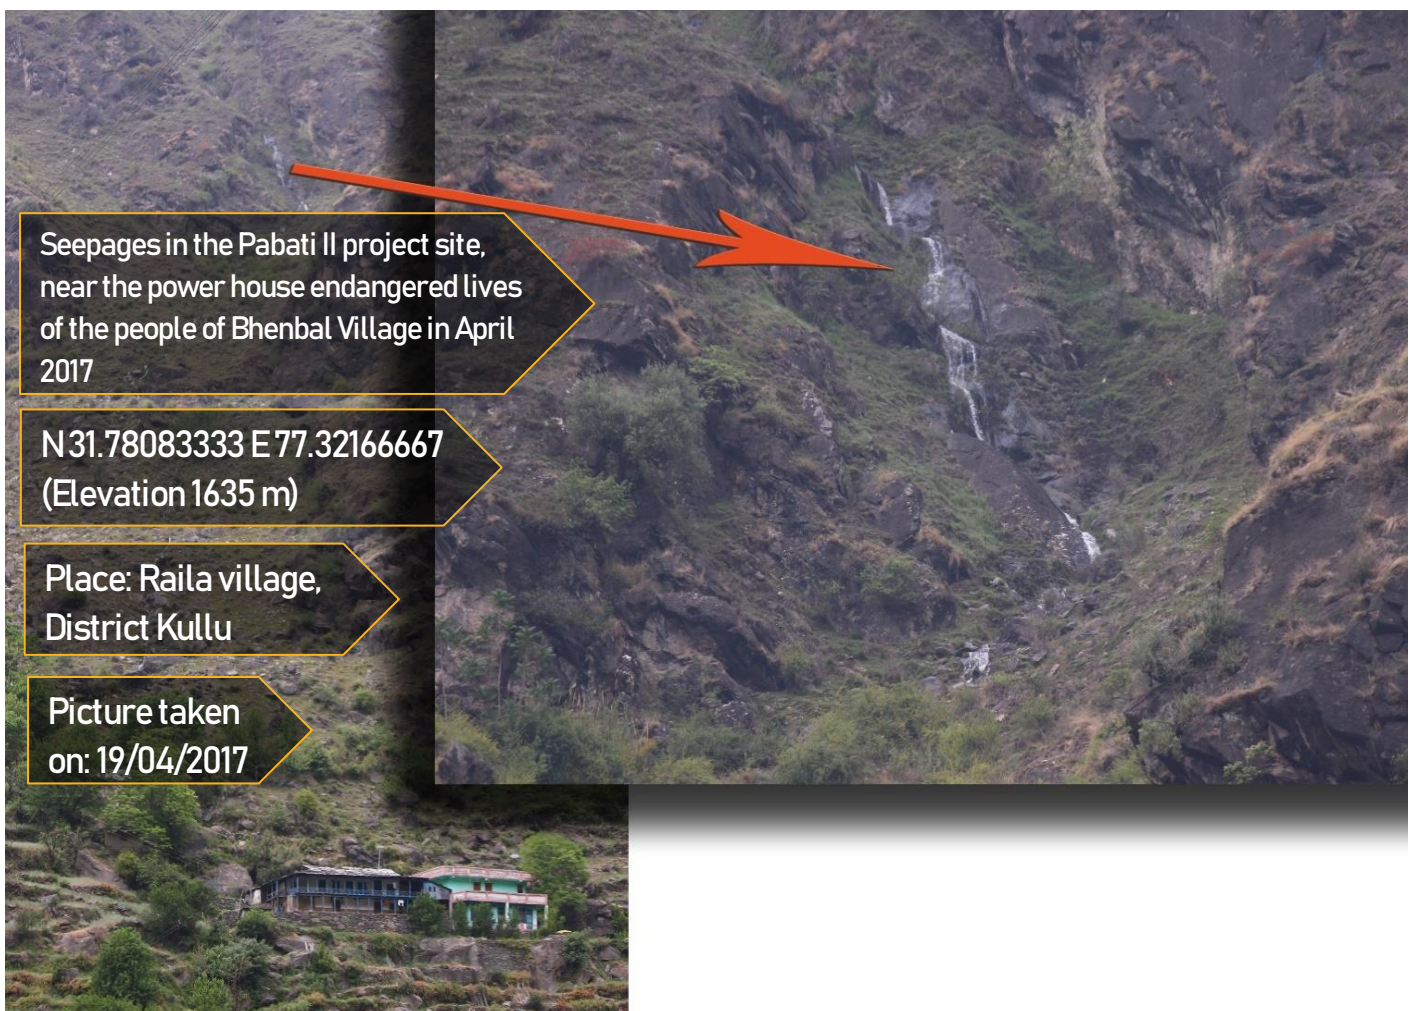
In **April 2017** when the project was testing before commissioning, about 20% of the water was released into the tunnel but there was a breach causing seepages near the surge shaft and power house. Residents of village Bhenbal "[spent their night under open sky for the fear of landslide](#)" and the leakage has also destroyed crops of the villagers. A few days later cracks also appeared near Relva village which is located along the alignment of the tunnel. A [detailed video report](#) shows residents of the village explain how the cracks appeared suddenly and now pose a serious threat to the area as villagers live in fear for their safety.

Seepages in the Pabati II project site, near the power house endangered lives of the people of Bhenbal Village in April 2017
