# THE HIDDEN COST OF HYDROPOWER

Environmental hazards & risks of tunnelling, excavation  
& construction in Run of the River Hydropower Projects  
in Himachal Pradesh

A Dossier | June 2019

**Himdharma, Environment Research & Action Collective**

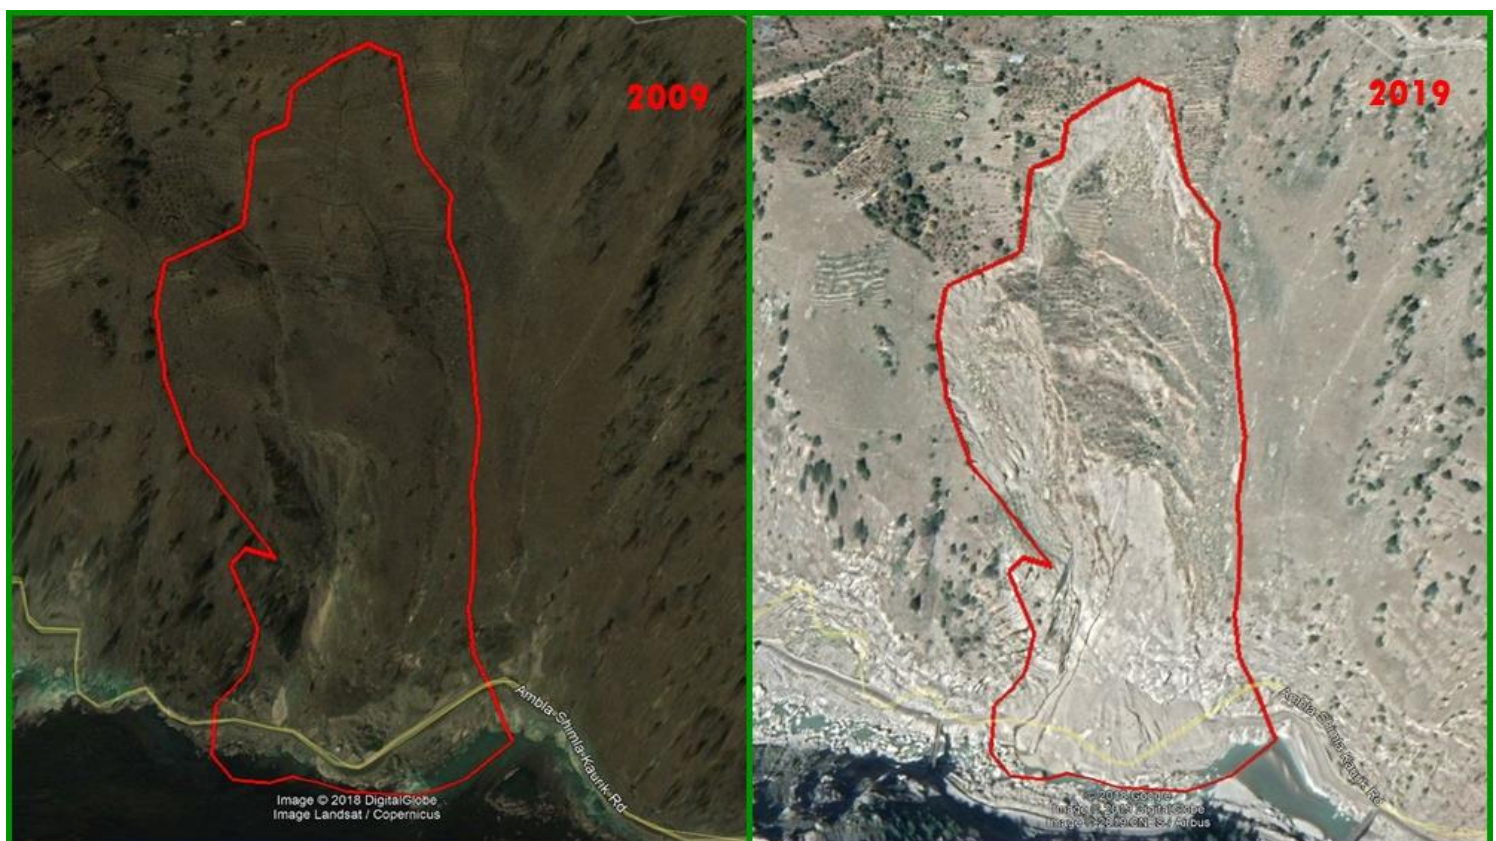
**Urni** is name of a village which is part of the Chagaon Panchayat located on the right bank of the Satluj river right and is well known for its 'dhank'. The term 'Dhank' refers to cliff or rock fall. This record dates back to 1992 and has been an active landslide for the last decade and a half. The graphic below compares google earth images of the land slide and its progression in the last ten years. 2009 was an important year for this region, as the construction work for the **1000 MW Karcham Wangtoo Hydro electric** project was underway through this very zone at the time. The village Urni today sits precariously above the junction of the flushing tunnel, Head Race tunnel and one of the Adit (approach) tunnels of this project. [Villagers narrate stories](#) of the severe blasting and drilling for the underground construction which has rendered this area even more weak and fractured from within, triggering the landslide further. More than 250 bighas of land of the village, mostly under apple orchards and people's homes, has developed cracks or slid down in the Urni landslide. The landslide according to experts is close to **600** meters long and **300** metres wide today ([Kumar et al](#)). In 2013, sudden and unexpectedly high rainfall, led to a severe slope failure which increased the intensity of the landslide and led to the formation of a dam on the Satluj river. This affected the movement of vehicles on NH 5 for close to 5 years, and vehicles had to take a 21 km detour on a village link road to cross the landslide affected area. While the government managed to re-open the main highway last year, the fate of the people of Urni continues to hang.

The **State Geologist** in an investigation carried out in May 2014 ruled out a possibility of the landslide having been caused due to project activities and put the responsibility on rainfall, temperature, accumulation of snow on debris in the winter and subsequent water stagnation and flood irrigation and other reasons. Citing 'natural calamity' as the driving factor also **deprives the community of claims for compensation** or rehabilitation for the loss of land on which they had dwellings and apple orchards.

It needs to be noted that the area of the Urni landslide lies between the Adit tunnels 3 and 4. This also happens to be the stretch where during the construction of the **17.2 km tunnel** of the Karchham Wangtoo project, work had to be suddenly halted due to a 'geological surprise' of unusually high temperatures (geo-thermal heat) near the Adit IV tunnel. While the Jaypee group was the power producer in this case and the affected communities had dragged the company to court for a variety of losses, the Urni issue remained unaddressed. In 2015 Jaypee sold the project to the Jindal group. But in most such cases it has also been found that since the construction work is in the hands of the contractor companies and not the owner of the project. The contractors though have information about the geological conditions, are expected to focus on project deadlines.

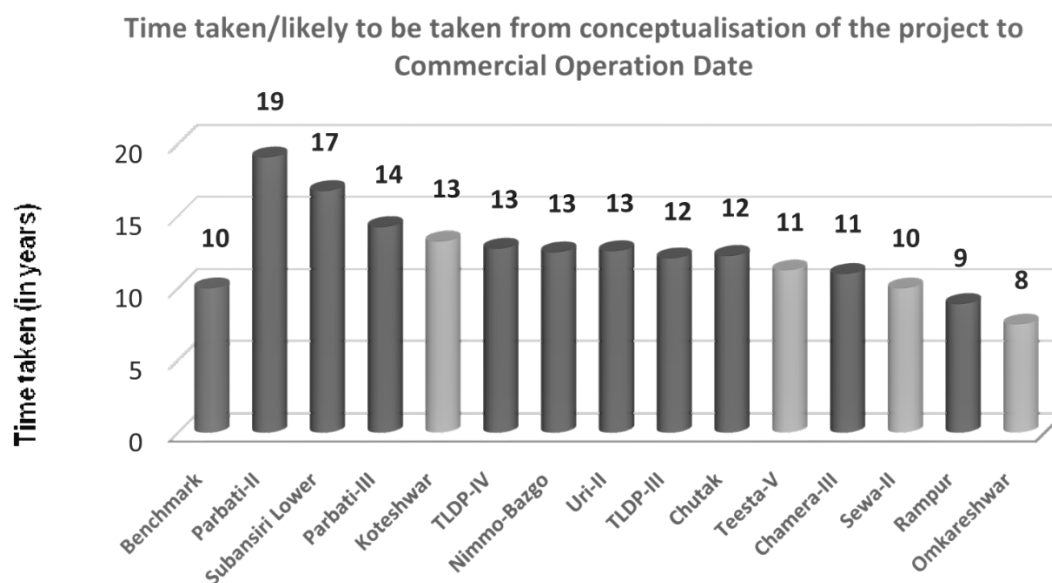
Source: CAG, Report No. 10 of 2012-13

The 800 MW Parbati II hydropower project has been under construction for the last two decades in the Kullu district of Himachal Pradesh. The original cost of the project was around Rs. 1300 crores at the time of planning and has crossed **8000 crores** currently. The ambitious design of the project involves diverting of the waters of the **Parbati** river over a 31.2 kilometer long tunnel into the Sainj river valley that runs parallel to the Parbati. The project has faced several 'geological surprises' during construction which have delayed the completion of the project. The poor geology near the dam and surge shaft sites have been cited in technical reports and status updates submitted to the **Central Electricity Authority**. Despite this, the project implementing authorities have failed to deal with these during their civil and construction works endangering the lives of people in the vicinity. As per a CAG report of 2012-13 which accounts for the causes of delays in these projects, "not taking all-embracing measures for power house back hill slope treatment after its first failure in April 2004 as a result of which it repeatedly failed in June 2006 and again in February 2007". This indicates the issue was faced in this site repeatedly since 2004.

In **April 2017** when the project was testing before commissioning, about 20% of the water was released into the tunnel but there was a breach causing seepages near the surge shaft and power house. Residents of village Bhenbal "[spent their night under open sky for the fear of landslide](#)" and the leakage has also destroyed crops of the villagers. A few days later cracks also appeared near Relva village which is located along the alignment of the tunnel. A [detailed video report](#) shows residents of the village explain how the cracks appeared suddenly and now pose a serious threat to the area as villagers live in fear for their safety.
